# Access Compliance Report

## Public Rights-of-Way

### (Curb Ramps)

| Intersection ID: 27788 | Main Street: PROVIDENCE_RD | Cross Street: PROVIDENCE_COUNTRY_CLUB_DR | Location: SE |

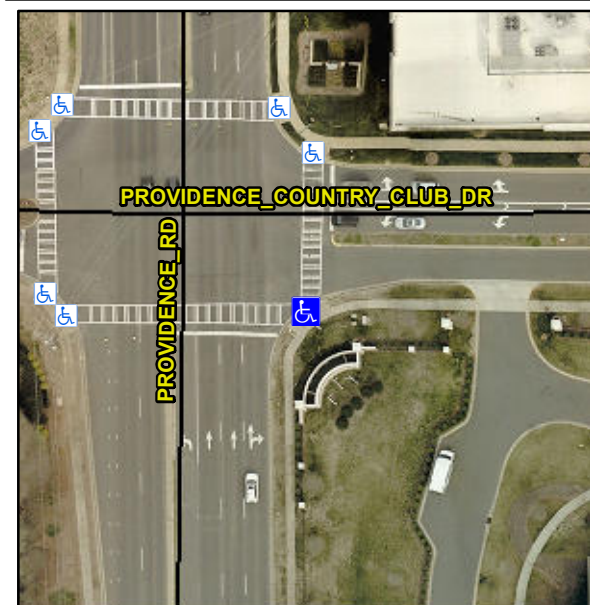
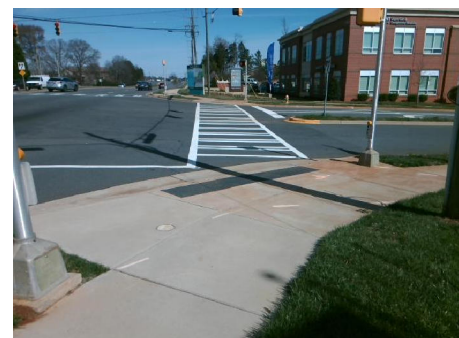
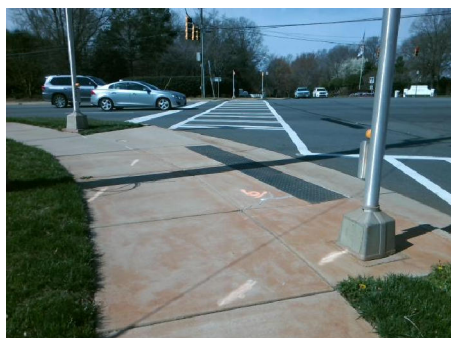
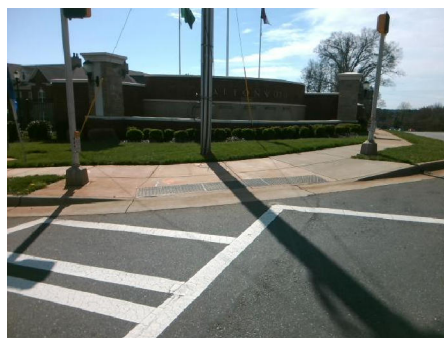
**Not Found, R304.5.3**

| Compliance | Description | Data | Compliance | Description | Data |
|---|---|---|---|---|---|
| Yes | Ramp Width (in) | 135.0 | No | BlendTrans XSlope (%) | 6.8 |

**Remove & Replace Curb Ramp With Two New Directional Ramps or Equivalent.**
