# Access Compliance Report

## Public Rights-of-Way (Curb Ramps)

Intersection ID: 44950	Main Street: WEAVERS_GLENN_PL	Cross Street: OLDCORN_LN	Location:	N
ADA ID: EF28A9FA8E89	Ramp Type: Perp	Initial Pass/Fail: Fail	Overall Compliance: No	Severity Score: 13.75

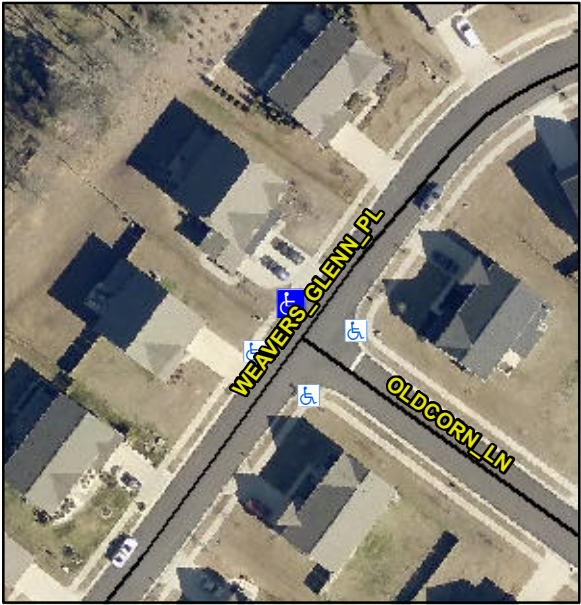
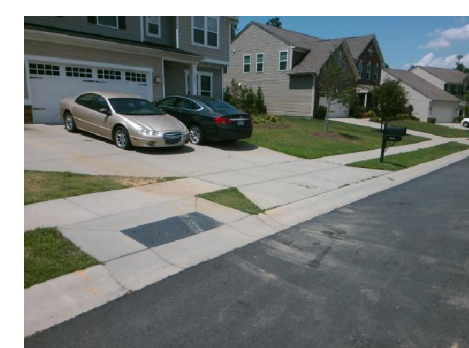
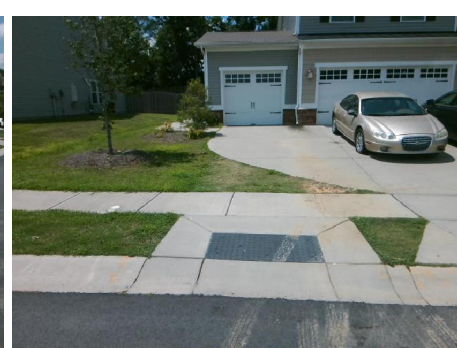
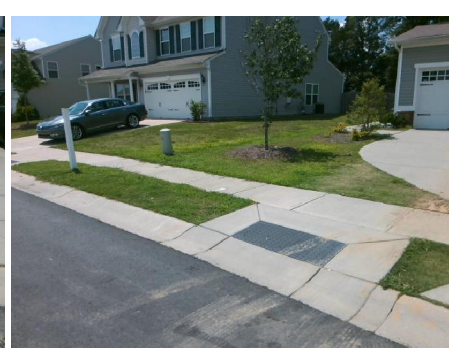
Possible Solutions:		<b>Compliance</b>	<b>Description</b>	<b>Data</b>
	<b>Remove &amp; Replace Entire Ramp.</b>		<b>No</b>	Ramp Slope (%)	<b>9.6</b>
			<b>Yes</b>	Ramp Width (in)	<b>2.2</b>
			<b>N/A</b>	Flare Type LT	<b>N/A</b>
			<b>N/A</b>	Flare Slope LT (%)	<b>N/A</b>
			<b>N/A</b>	Flare Traversable LT?	<b>N/A</b>
			<b>N/A</b>	Landing Length (in)	<b>N/A</b>
			<b>N/A</b>	Landing Width (in)	<b>N/A</b>
			<b>N/A</b>	Landing Slope (%)	<b>N/A</b>
			<b>N/A</b>	Landing X Slope (%)	<b>N/A</b>
<p>Surveyor Notes:</p> <p><b>N/A</b></p> <p>PROW/ADA:</p> <p><b>Not Found, R304.2.2</b></p>			<b>N/A</b>	Flare Type RT	<b>N/A</b>
			<b>N/A</b>	Flare Slope RT (%)	<b>N/A</b>
			<b>N/A</b>	Flare Traversable RT?	<b>N/A</b>
			<b>N/A</b>	DWS Provided?	<b>N/A</b>
			<b>N/A</b>	DWS Contrast?	<b>N/A</b>
			<b>N/A</b>	DWS Length (in)	<b>N/A</b>

<b>N/A</b>	DWS Full Width?	<b>N/A</b>
			<b>N/A</b>	DWS Offset (in)	<b>N/A</b>
			<b>N/A</b>	Gutter Ponding?	<b>N/A</b>
			<b>N/A</b>	Gutter Lip Ht (in)	<b>N/A</b>
<p>Total Cost:</p> <p><b>\$ 1850.00</b></p>			<b>No</b>	Painted X Walk2?	<b>N/A</b>
			<b>To SE</b>	X Walk 2 Direction	<b>N/A</b>
			<b>N/A</b>	X Walk 2 Width (in)	<b>N/A</b>
			<b>3.9</b>	X Walk 2 Slope (%)	<b>N/A</b>
			<b>2.4</b>	X Walk 2 X Slope (%)	<b>N/A</b>
			<b>N/A</b>	Ramp inside XWalk2?	<b>N/A</b>
			<b>N/A</b>	Clear Space?	<b>N/A</b>
			<b>N/A</b>	Clear Space to XWalk (in)	<b>N/A</b>
			<b>N/A</b>	Storm Grate/Utility Hazard?	<b>N/A</b>
			<b>N/A</b>	Storm Grate/Utility Type	<b>N/A</b>
			<b>N/A</b>	Surface Condition? (G/P)	<b>Good</b>
