Access Compliance Report

Public Rights-of-Way

(Curb Ramps)

Intersection ID: 42942	Main Street: LONG_PAW_LN	Cross Street: REMICK_CT	Location: NW
ADA ID: EF2D7A1DE480	Ramp Type: PerpDiag	Initial Pass/Fail: Fail	Overall Compliance: No
			Severity Score: 33.75

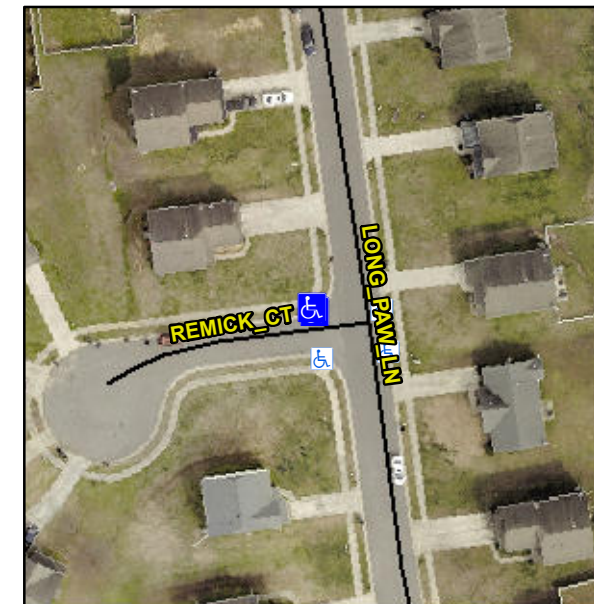
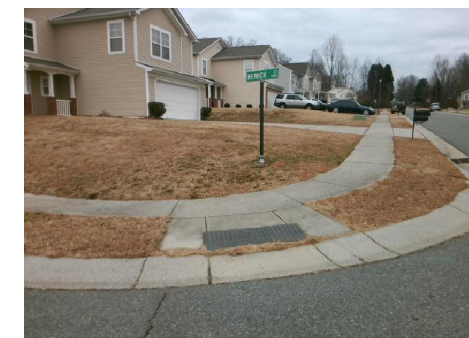
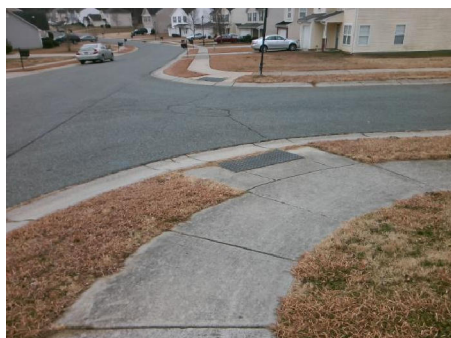
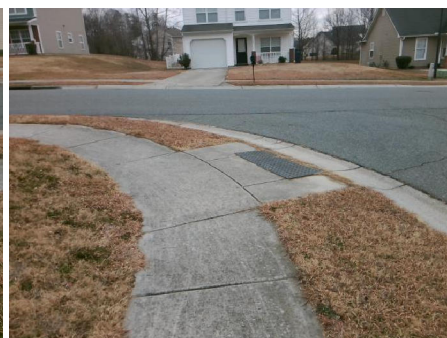
Not Found, R304.5.1, R304.2.2, R304.5.3

Compliance	Description	Data	Compliance	Description	Data
N/A	Ramp Length (in)	48.5	No	Ramp Slope (%)	8.4
No	Ramp Width (in)	39.0	No	Ramp XSlope (%)	5.6
N/A	Flare Type LT	N/A	N/A	Flare Type RT	N/A
N/A	Flare Slope LT (%)	N/A	N/A	Flare Slope RT (%)	N/A
N/A	Flare Traversable LT?	N/A	N/A	Flare Traversable RT?	N/A
N/A	Landing Length (in)	N/A	N/A	DWS Provided?	N/A
N/A	Landing Width (in)	N/A	N/A	DWS Contrast?	N/A
N/A	Landing Slope (%)	N/A	N/A	DWS Length (in)	N/A
N/A	Landing X Slope (%)	N/A	N/A	DWS Full Width?	N/A
N/A	Landing Curb? (Y/N)	N/A	N/A	DWS Offset (in)	N/A
N/A	Shared Landing?	N/A			
N/A	Gutter Ponding?	N/A	N/A	Gutter Slope (%)	N/A
N/A	Gutter Lip Ht (in)	N/A	N/A	Gutter X Slope (%)	N/A
N/A	Painted X Walk1?	No	N/A	Painted X Walk2?	No
	X Walk 1 Direction	To S		X Walk 2 Direction	To E
N/A	X Walk 1 Width (in)	N/A	N/A	X Walk 2 Width (in)	N/A
	X Walk 1 Slope (%)	0.2		X Walk 2 Slope (%)	5.2
	X Walk 1 X Slope (%)	5.6		X Walk 2 X Slope (%)	1.8

N/A	Ramp inside XWalk1?	N/A	N/A	Ramp inside XWalk2?	N/A
	Road Slope (%)	5.0	N/A	Clear Space?	N/A
	Road X Slope (%)	4.7	N/A	Clear Space to XWalk (in)	N/A
N/A	Any Obstructions?	N/A	N/A	Storm Grate/Utility Hazard?	N/A
	Obstruction Type			Storm Grate/Utility Type	
		N/A			N/A
			Yes	Surface Condition? (G/P)	Good

Remove & Replace Curb Ramp With Two New Directional Ramps or Equivalent.
