# Access Compliance Report

## Public Rights-of-Way

### (Curb Ramps)

| Intersection ID: 28662 | Main Street: MEADOWMONT_DR | Cross Street: MEADOWMONT_VIEW_DR | Location: NE |

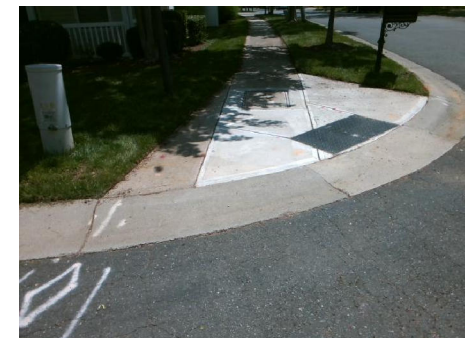
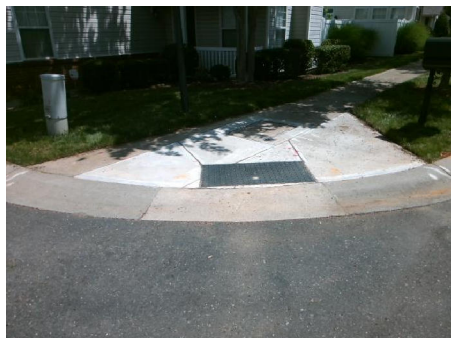
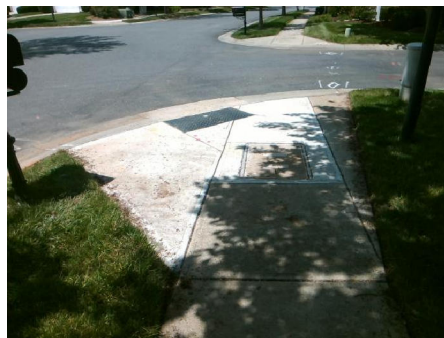
| | | | Severity Score: 7.5 |

| Compliance | Description | Data | Compliance | Description | Data |
|---|---|---|---|---|---|
| No | Landing Length (in) | 32.0 | Yes | DWS Provided? | Yes |
| No | Landing Slope (%) | 2.3 | Yes | DWS Length (in) | 24.0 |
| No | Gutter Lip Ht (in) | 0.3 | Yes | Gutter X Slope (%) | 0.4 |

Possible Solutions:

**Remove & Replace Landing. Grind Gutter Lip.**

Total Cost: \$ 700.00
