Access Compliance Report

Public Rights-of-Way

(Curb Ramps)

Intersection ID: 2969	Main Street: CREEK_BREEZE_RD	Cross Street: MEADOW_GREEN_DR	Location: SW
ADA ID: EF4D5FCBFC43	Ramp Type: PerpDiag	Initial Pass/Fail: Fail	Overall Compliance: No
			Severity Score: 21.25

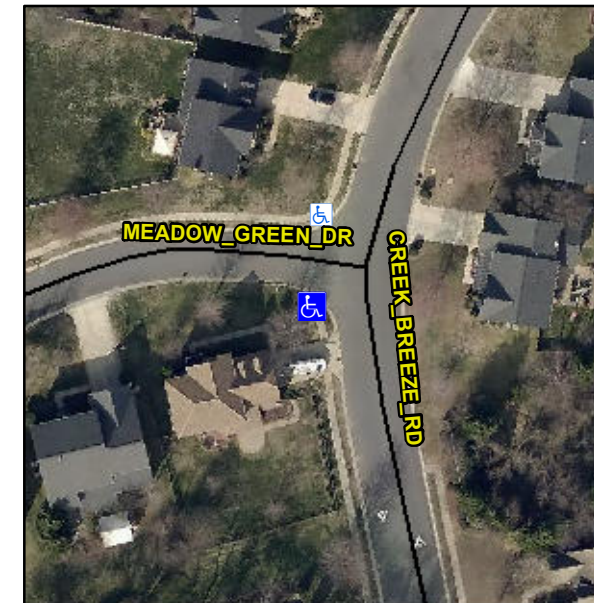
Not Found, R304.5.1, R304.2.2

Compliance	Description	Data	Compliance	Description	Data
N/A	Ramp Length (in)	40.0	No	Ramp Slope (%)	11.9
No	Ramp Width (in)	44.0	Yes	Ramp XSlope (%)	0.3
N/A	Flare Type LT	N/A	N/A	Flare Type RT	N/A
N/A	Flare Slope LT (%)	N/A	N/A	Flare Slope RT (%)	N/A
N/A	Flare Traversable LT?	N/A	N/A	Flare Traversable RT?	N/A
N/A	Landing Length (in)	N/A	N/A	DWS Provided?	N/A
N/A	Landing Width (in)	N/A	N/A	DWS Contrast?	N/A
N/A	Landing Slope (%)	N/A	N/A	DWS Length (in)	N/A
N/A	Landing X Slope (%)	N/A	N/A	DWS Full Width?	N/A
N/A	Landing Curb? (Y/N)	N/A	N/A	DWS Offset (in)	N/A
N/A	Shared Landing?	N/A			
N/A	Gutter Ponding?	N/A	N/A	Gutter Slope (%)	N/A
N/A	Gutter Lip Ht (in)	N/A	N/A	Gutter X Slope (%)	N/A
N/A	Painted X Walk1?	No	N/A	Painted X Walk2?	No
	X Walk 1 Direction	To E		X Walk 2 Direction	To N
N/A	X Walk 1 Width (in)	N/A	N/A	X Walk 2 Width (in)	N/A
	X Walk 1 Slope (%)	0.6		X Walk 2 Slope (%)	1.3
	X Walk 1 X Slope (%)	0.3		X Walk 2 X Slope (%)	0.1

N/A	Ramp inside XWalk1?	N/A	N/A	Ramp inside XWalk2?	N/A
	Road Slope (%)	1.4	N/A	Clear Space?	N/A
	Road X Slope (%)	0.1	N/A	Clear Space to XWalk (in)	N/A
N/A	Any Obstructions?	N/A	N/A	Storm Grate/Utility Hazard?	N/A
	Obstruction Type			Storm Grate/Utility Type	
		N/A			N/A
			Yes	Surface Condition? (G/P)	Good

Remove & Replace Curb Ramp With Two New Directional Ramps or Equivalent.
