# Access Compliance Report

## Public Rights-of-Way

### (Curb Ramps)

Intersection ID: 30412	Main Street: COVENTRY_ROW_CT	Cross Street: SARDIS_RD	Location: E
ADA ID: EF556DB3B712	Ramp Type: PerpDiag	Initial Pass/Fail: Fail	Overall Compliance: No
		Severity Score: 8.75

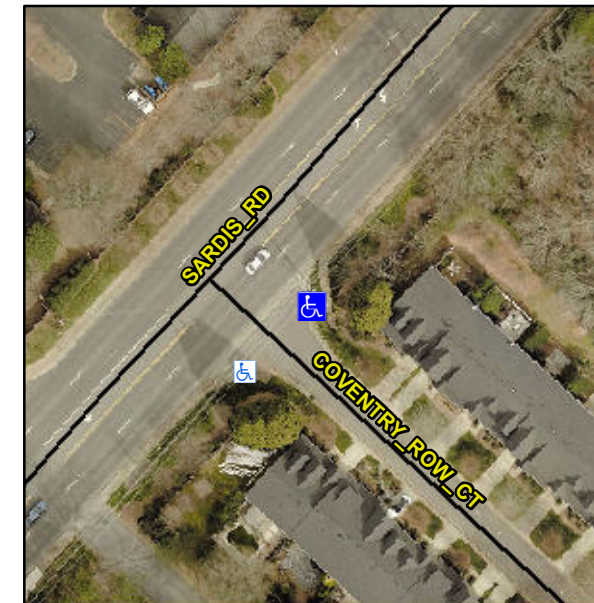
**Not Found, R304.5.1**

Compliance	Description	Data	Compliance	Description	Data
N/A	Ramp Length (in)	82.0	Yes	Ramp Slope (%)	8.0
No	Ramp Width (in)	39.0	Yes	Ramp XSlope (%)	2.0
N/A	Flare Type LT	N/A	N/A	Flare Type RT	N/A
N/A	Flare Slope LT (%)	N/A	N/A	Flare Slope RT (%)	N/A
N/A	Flare Traversable LT?	N/A	N/A	Flare Traversable RT?	N/A
N/A	Landing Length (in)	N/A	N/A	DWS Provided?	N/A
N/A	Landing Width (in)	N/A	N/A	DWS Contrast?	N/A
N/A	Landing Slope (%)	N/A	N/A	DWS Length (in)	N/A
N/A	Landing X Slope (%)	N/A	N/A	DWS Full Width?	N/A
N/A	Landing Curb? (Y/N)	N/A	N/A	DWS Offset (in)	N/A
N/A	Shared Landing?	N/A			
N/A	Gutter Ponding?	N/A	N/A	Gutter Slope (%)	N/A
N/A	Gutter Lip Ht (in)	N/A	N/A	Gutter X Slope (%)	N/A
N/A	Painted X Walk1?	No	N/A	Painted X Walk2?	No
	X Walk 1 Direction	To NW		X Walk 2 Direction	To SW
N/A	X Walk 1 Width (in)	N/A	N/A	X Walk 2 Width (in)	N/A
	X Walk 1 Slope (%)	0.6		X Walk 2 Slope (%)	0.9
	X Walk 1 X Slope (%)	1.1		X Walk 2 X Slope (%)	0.9

N/A	Ramp inside XWalk1?	N/A	N/A	Ramp inside XWalk2?	N/A
	Road Slope (%)	0.4	N/A	Clear Space?	N/A
	Road X Slope (%)	1.4	N/A	Clear Space to XWalk (in)	N/A
N/A	Any Obstructions?	N/A	N/A	Storm Grate/Utility Hazard?	N/A
	Obstruction Type			Storm Grate/Utility Type	
		N/A			N/A
			Yes	Surface Condition? (G/P)	Good

**Remove & Replace Curb Ramp With Two New Directional Ramps or Equivalent.**
