Access Compliance Report

Public Rights-of-Way

(Curb Ramps)

Intersection ID: 15763	Main Street: MONROE_RD	Cross Street: N_WENDOVER_RD	Location: W
ADA ID: EF56537CDF8E	Ramp Type: PerpDiag	Initial Pass/Fail: Fail	Overall Compliance: No
Severity Score: 8.75			
Codes/Mitigation Info/Possible Solution		Field Measurements/Component Compliance

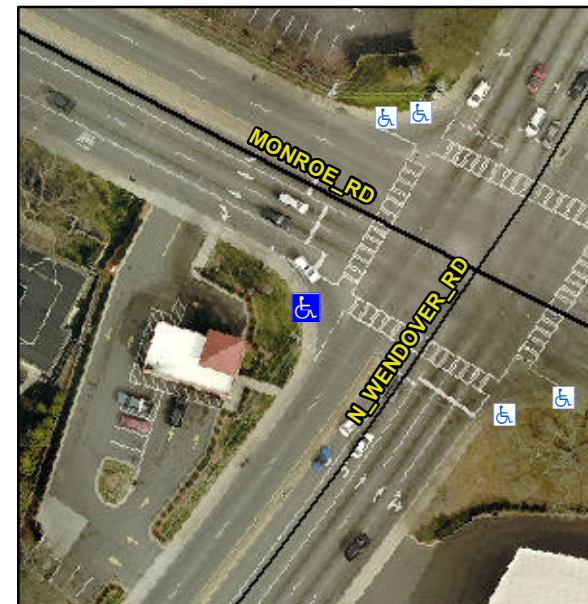
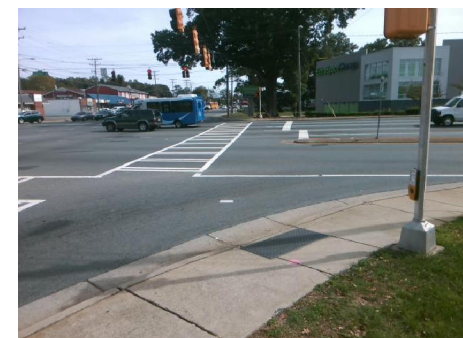
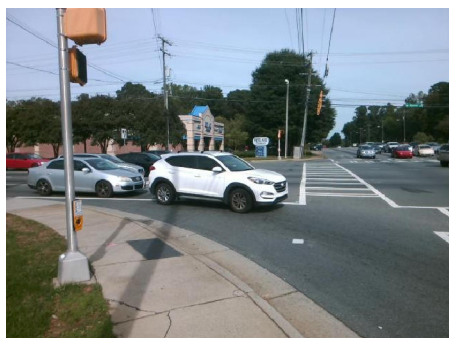
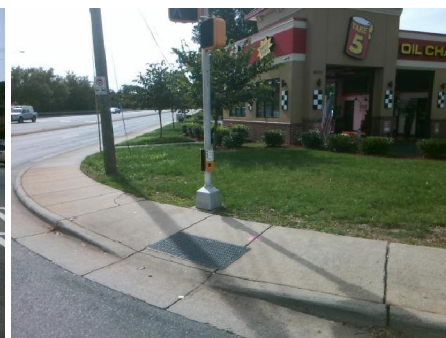
Not Found, R304.5.1

Compliance	Description	Data	Compliance	Description	Data
N/A	Ramp Length (in)	60.0	Yes	Ramp Slope (%)	6.4
No	Ramp Width (in)	41.0	Yes	Ramp XSlope (%)	0.1
N/A	Flare Type LT	N/A	N/A	Flare Type RT	N/A
N/A	Flare Slope LT (%)	N/A	N/A	Flare Slope RT (%)	N/A
N/A	Flare Traversable LT?	N/A	N/A	Flare Traversable RT?	N/A
N/A	Landing Length (in)	N/A	N/A	DWS Provided?	N/A
N/A	Landing Width (in)	N/A	N/A	DWS Contrast?	N/A
N/A	Landing Slope (%)	N/A	N/A	DWS Length (in)	N/A
N/A	Landing X Slope (%)	N/A	N/A	DWS Full Width?	N/A
N/A	Landing Curb? (Y/N)	N/A	N/A	DWS Offset (in)	N/A
N/A	Shared Landing?	N/A			
N/A	Gutter Ponding?	N/A	N/A	Gutter Slope (%)	N/A
N/A	Gutter Lip Ht (in)	N/A	N/A	Gutter X Slope (%)	N/A
N/A	Painted X Walk1?	Yes	N/A	Painted X Walk2?	Yes
	X Walk 1 Direction	To SE		X Walk 2 Direction	To NE
N/A	X Walk 1 Width (in)	107.0	N/A	X Walk 2 Width (in)	107.0
	X Walk 1 Slope (%)	0.9		X Walk 2 Slope (%)	0.6
	X Walk 1 X Slope (%)	0.5		X Walk 2 X Slope (%)	1.0

N/A	Ramp inside XWalk1?	Yes	N/A	Ramp inside XWalk2?	No
	Road Slope (%)	0.4	N/A	Clear Space?	N/A
	Road X Slope (%)	2.0	N/A	Clear Space to XWalk (in)	N/A
N/A	Any Obstructions?	N/A	N/A	Storm Grate/Utility Hazard?	N/A
	Obstruction Type			Storm Grate/Utility Type	
		N/A			N/A
		Yes		Surface Condition? (G/P)	Good

Remove & Replace Curb Ramp With Two New Directional Ramps or Equivalent. Restripe Crosswalk.
