Access Compliance Report

Public Rights-of-Way

(Curb Ramps)

Intersection ID: 5227	Main Street: CAMERON_SPRING_RD	Cross Street: EVENTINE_CT	Location:	E
ADA ID: EF5784CF17B7	Ramp Type: Perp	Initial Pass/Fail: Fail	Overall Compliance: No	Severity Score: 22.5
Codes/Mitigation Info/Possible Solution		Field Measurements/Component Compliance

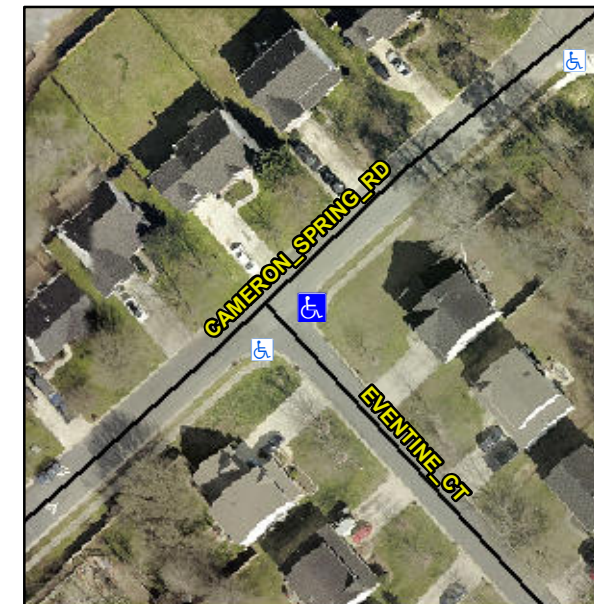
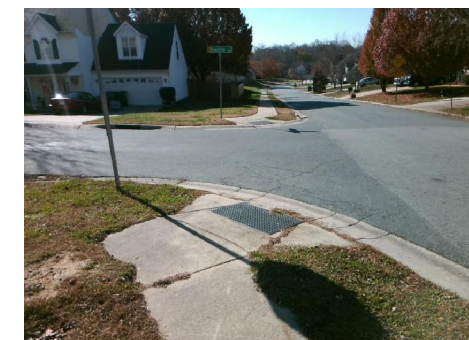
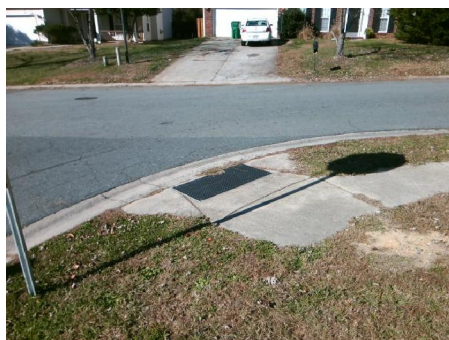
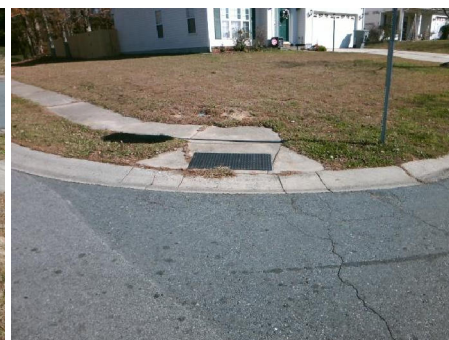
Not Found, R304.5.1, R304.2.2, R304.5.3

Compliance	Description	Data	Compliance	Description	Data
N/A	Ramp Length (in)	47.0	No	Ramp Slope (%)	9.0
No	Ramp Width (in)	43.0	No	Ramp XSlope (%)	4.5
N/A	Flare Type LT	N/A	N/A	Flare Type RT	N/A
N/A	Flare Slope LT (%)	N/A	N/A	Flare Slope RT (%)	N/A
N/A	Flare Traversable LT?	N/A	N/A	Flare Traversable RT?	N/A
N/A	Landing Length (in)	N/A	N/A	DWS Provided?	N/A
N/A	Landing Width (in)	N/A	N/A	DWS Contrast?	N/A
N/A	Landing Slope (%)	N/A	N/A	DWS Length (in)	N/A
N/A	Landing X Slope (%)	N/A	N/A	DWS Full Width?	N/A
N/A	Landing Curb? (Y/N)	N/A	N/A	DWS Offset (in)	N/A
N/A	Shared Landing?	N/A			
N/A	Gutter Ponding?	N/A	N/A	Gutter Slope (%)	N/A
N/A	Gutter Lip Ht (in)	N/A	N/A	Gutter X Slope (%)	N/A
N/A	Painted X Walk1?	No	N/A	Painted X Walk2?	N/A
	X Walk 1 Direction	To SW		X Walk 2 Direction	N/A
N/A	X Walk 1 Width (in)	N/A	N/A	X Walk 2 Width (in)	N/A
	X Walk 1 Slope (%)	3.2		X Walk 2 Slope (%)	N/A
	X Walk 1 X Slope (%)	0.5		X Walk 2 X Slope (%)	N/A

N/A	Ramp inside XWalk1?	N/A	N/A	Ramp inside XWalk2?	N/A
	Road Slope (%)	N/A	N/A	Clear Space?	N/A
	Road X Slope (%)	N/A	N/A	Clear Space to XWalk (in)	N/A
N/A	Any Obstructions?	N/A	N/A	Storm Grate/Utility Hazard?	N/A
	Obstruction Type			Storm Grate/Utility Type	
		N/A			N/A
			Yes	Surface Condition? (G/P)	Good

Remove & Replace Entire Ramp.

\$ 1850.00
