Access Compliance Report

Public Rights-of-Way

(Curb Ramps)

Intersection ID: 47616	Main Street: TWISTED_PINE_DR	Cross Street: CANIPE_DR	Location: W
ADA ID: EF5BD1E637ED	Ramp Type: Perp	Initial Pass/Fail: Fail	Overall Compliance: No
Severity Score: 13.75			
Codes/Mitigation Info/Possible Solution		Field Measurements/Component Compliance

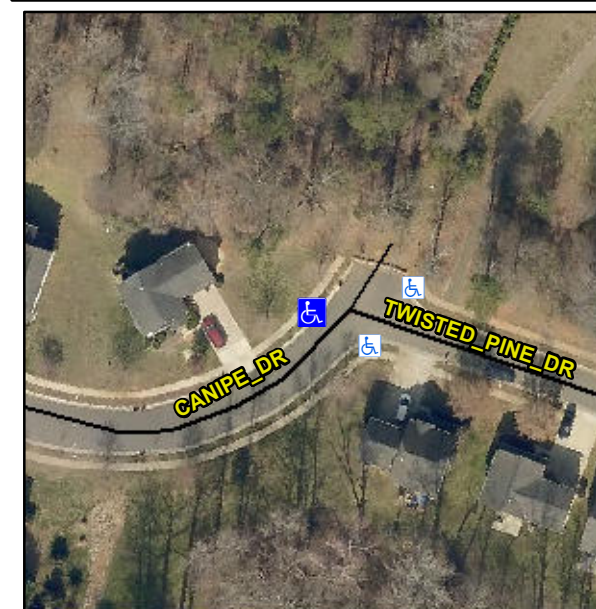
Not Found, R304.2.2, R304.5.3

Compliance	Description	Data	Compliance	Description	Data
N/A	Ramp Length (in)	48.5	No	Ramp Slope (%)	9.4
Yes	Ramp Width (in)	48.0	No	Ramp XSlope (%)	2.6
N/A	Flare Type LT	N/A	N/A	Flare Type RT	N/A
N/A	Flare Slope LT (%)	N/A	N/A	Flare Slope RT (%)	N/A
N/A	Flare Traversable LT?	N/A	N/A	Flare Traversable RT?	N/A
N/A	Landing Length (in)	N/A	N/A	DWS Provided?	N/A
N/A	Landing Width (in)	N/A	N/A	DWS Contrast?	N/A
N/A	Landing Slope (%)	N/A	N/A	DWS Length (in)	N/A
N/A	Landing X Slope (%)	N/A	N/A	DWS Full Width?	N/A
N/A	Landing Curb? (Y/N)	N/A	N/A	DWS Offset (in)	N/A
N/A	Shared Landing?	N/A			
N/A	Gutter Ponding?	N/A	N/A	Gutter Slope (%)	N/A
N/A	Gutter Lip Ht (in)	N/A	N/A	Gutter X Slope (%)	N/A
N/A	Painted X Walk1?	No	N/A	Painted X Walk2?	N/A
	X Walk 1 Direction	To SE		X Walk 2 Direction	N/A
N/A	X Walk 1 Width (in)	N/A	N/A	X Walk 2 Width (in)	N/A
	X Walk 1 Slope (%)	2.5		X Walk 2 Slope (%)	N/A
	X Walk 1 X Slope (%)	2.4		X Walk 2 X Slope (%)	N/A

N/A	Ramp inside XWalk1?	N/A	N/A	Ramp inside XWalk2?	N/A
	Road Slope (%)	N/A	N/A	Clear Space?	N/A
	Road X Slope (%)	N/A	N/A	Clear Space to XWalk (in)	N/A
N/A	Any Obstructions?	N/A	N/A	Storm Grate/Utility Hazard?	N/A
	Obstruction Type			Storm Grate/Utility Type	
		N/A			N/A
			Yes	Surface Condition? (G/P)	Good

Possible Solutions:

Remove & Replace Entire Ramp.
