Access Compliance Report

Public Rights-of-Way

(Curb Ramps)

Intersection ID: 10037289	Main Street: SARDIS_RD_NORTH	Cross Street: N/A	Location: N
ADA ID: EF6B111349F5	Ramp Type: Perp	Initial Pass/Fail: Fail	Overall Compliance: No
Severity Score: 36.25			
Codes/Mitigation Info/Possible Solution		Field Measurements/Component Compliance

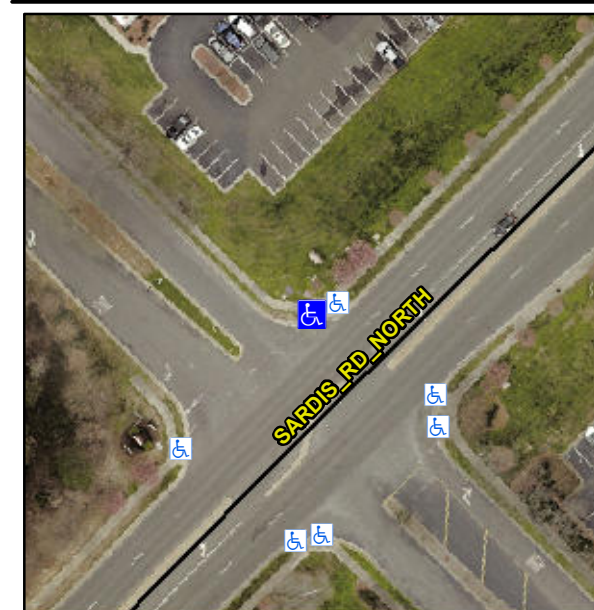
Compliance	Description	Data	Compliance	Description	Data
N/A	Ramp Length (in)	70.0	No	Ramp Slope (%)	10.2
No	Ramp Width (in)	44.0	Yes	Ramp XSlope (%)	1.4
N/A	Flare Type LT	N/A	N/A	Flare Type RT	N/A
N/A	Flare Slope LT (%)	N/A	N/A	Flare Slope RT (%)	N/A
N/A	Flare Traversable LT?	N/A	N/A	Flare Traversable RT?	N/A
N/A	Landing Length (in)	N/A	N/A	DWS Provided?	N/A
N/A	Landing Width (in)	N/A	N/A	DWS Contrast?	N/A
N/A	Landing Slope (%)	N/A	N/A	DWS Length (in)	N/A
N/A	Landing X Slope (%)	N/A	N/A	DWS Full Width?	N/A
N/A	Landing Curb? (Y/N)	N/A	N/A	DWS Offset (in)	N/A
N/A	Shared Landing?	N/A			
N/A	Gutter Ponding?	N/A	N/A	Gutter Slope (%)	N/A
N/A	Gutter Lip Ht (in)	0.5	N/A	Gutter X Slope (%)	N/A
N/A	Painted X Walk1?	No	N/A	Painted X Walk2?	N/A
	X Walk 1 Direction	To SW		X Walk 2 Direction	N/A
N/A	X Walk 1 Width (in)	N/A	N/A	X Walk 2 Width (in)	N/A
	X Walk 1 Slope (%)	0.5		X Walk 2 Slope (%)	N/A
	X Walk 1 X Slope (%)	2.2		X Walk 2 X Slope (%)	N/A

N/A	Ramp inside XWalk1?	N/A	N/A	Ramp inside XWalk2?	N/A
	Road Slope (%)	N/A	N/A	Clear Space?	N/A
	Road X Slope (%)	N/A	N/A	Clear Space to XWalk (in)	N/A
N/A	Any Obstructions?	N/A	N/A	Storm Grate/Utility Hazard?	N/A
	Obstruction Type			Storm Grate/Utility Type	
		N/A			N/A
		No		Surface Condition? (G/P)	Poor

Possible Solutions:

Remove & Replace Entire Ramp.

R304.5.1, R304.2.2, R302.7
