## Access Compliance Report Public Rights-of-Way (Curb Ramps)

Intersection ID: 11408 Main Street: N\_SMITH\_ST Cross Street: W\_8TH\_ST Location: S

ADA ID: EF6FE16B9F40 Ramp Type: PerpDiag Initial Pass/Fail: Fail Overall Compliance: No Severity Score: 10

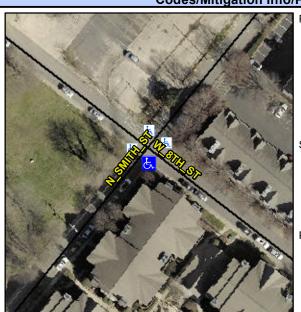
Not Found R304 5 1 R304 5 3

Compliance Description		Data	Comp	liance Description	Data
N/A	Ramp Length (in)	66.0	Yes	Ramp Slope (%)	6.0
No	Ramp Width (in)	39.0	No	Ramp XSlope (%)	3.9
N/A	Flare Type LT	N/A	N/A	Flare Type RT	N/A
N/A	Flare Slope LT (%)	N/A	N/A	Flare Slope RT (%)	N/A
N/A	Flare Traversable LT?	N/A	N/A	Flare Traversable RT?	N/A
N/A	Landing Length (in)	N/A	N/A	DWS Provided?	N/A
N/A	Landing Width (in)	N/A	N/A	DWS Contrast?	N/A
N/A	Landing Slope (%)	N/A	N/A	DWS Length (in)	N/A
N/A	Landing X Slope (%)	N/A	N/A	DWS Full Width?	N/A
N/A	Landing Curb? (Y/N)	N/A	N/A	DWS Offset (in)	N/A
N/A	Shared Landing?	N/A			
N/A	Gutter Ponding?	N/A	N/A	Gutter Slope (%)	N/A
N/A	Gutter Lip Ht (in)	N/A	N/A	Gutter X Slope (%)	N/A
N/A	Painted X Walk1?	No	N/A	Painted X Walk2?	No
	X Walk 1 Direction	To NE		X Walk 2 Direction	To NW
N/A	X Walk 1 Width (in)	N/A	N/A	X Walk 2 Width (in)	N/A
	X Walk 1 Slope (%)	5.4		X Walk 2 Slope (%)	1.8
	X Walk 1 X Slope (%)	2.9		X Walk 2 X Slope (%)	6.4

N/A	Ramp inside XWalk1?	N/A	N/A	Ramp inside XWalk2?	N/A
	Road Slope (%)	0.8	N/A	Clear Space?	N/A
	Road X Slope (%)	9.2	N/A	Clear Space to XWalk (in)	N/A
N/A	Any Obstructions?	N/A	N/A	Storm Grate/Utility Hazard?	N/A
	Obstruction Type		l	Storm Grate/Utility Type	
		N/A			N/A

Remove & Replace Curb Ramp With
Two New Directional Ramps or
Equivalent.
