Access Compliance Report

Public Rights-of-Way

(Curb Ramps)

Intersection ID: 29629	Main Street: WINGET_RD	Cross Street: PLANTERS_ESTATES_DR	Location: SE
ADA ID: EF78B4C92BC5	Ramp Type: PerpDiag	Initial Pass/Fail: Fail	Overall Compliance: No
Codes/Mitigation Info/Possible Solution		Field Measurements/Component Compliance	
Severity Score: 8.75

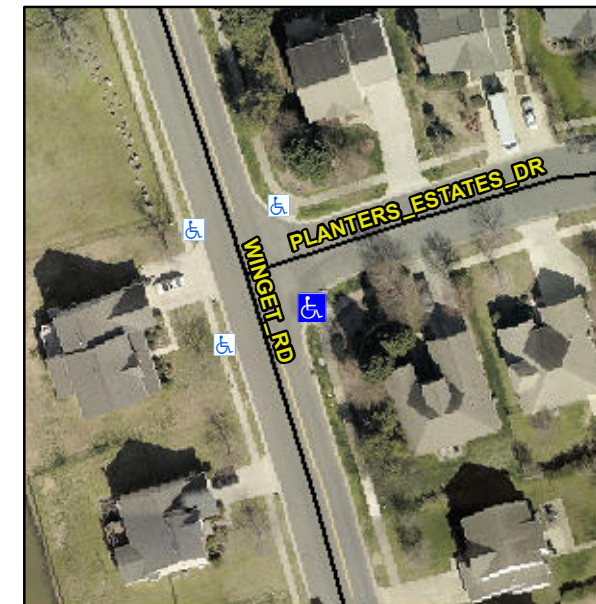
Not Found, R304.5.1

Compliance	Description	Data	Compliance	Description	Data
N/A	Ramp Length (in)	84.0	Yes	Ramp Slope (%)	5.2
No	Ramp Width (in)	40.0	Yes	Ramp XSlope (%)	0.5
N/A	Flare Type LT	N/A	N/A	Flare Type RT	N/A
N/A	Flare Slope LT (%)	N/A	N/A	Flare Slope RT (%)	N/A
N/A	Flare Traversable LT?	N/A	N/A	Flare Traversable RT?	N/A
N/A	Landing Length (in)	N/A	N/A	DWS Provided?	N/A
N/A	Landing Width (in)	N/A	N/A	DWS Contrast?	N/A
N/A	Landing Slope (%)	N/A	N/A	DWS Length (in)	N/A
N/A	Landing X Slope (%)	N/A	N/A	DWS Full Width?	N/A
N/A	Landing Curb? (Y/N)	N/A	N/A	DWS Offset (in)	N/A
N/A	Shared Landing?	N/A			
N/A	Gutter Ponding?	N/A	N/A	Gutter Slope (%)	N/A
N/A	Gutter Lip Ht (in)	N/A	N/A	Gutter X Slope (%)	N/A
N/A	Painted X Walk1?	No	N/A	Painted X Walk2?	No
	X Walk 1 Direction	To N		X Walk 2 Direction	To W
N/A	X Walk 1 Width (in)	N/A	N/A	X Walk 2 Width (in)	N/A
	X Walk 1 Slope (%)	0.4		X Walk 2 Slope (%)	2.8
	X Walk 1 X Slope (%)	0.6		X Walk 2 X Slope (%)	0.2

N/A	Ramp inside XWalk1?	N/A	N/A	Ramp inside XWalk2?	N/A
	Road Slope (%)	0.3	N/A	Clear Space?	N/A
	Road X Slope (%)	0.9	N/A	Clear Space to XWalk (in)	N/A
N/A	Any Obstructions?	N/A	N/A	Storm Grate/Utility Hazard?	N/A
	Obstruction Type			Storm Grate/Utility Type	
		N/A			N/A
			Yes	Surface Condition? (G/P)	Good

Remove & Replace Curb Ramp With Two New Directional Ramps or Equivalent.
