Access Compliance Report Public Rights-of-Way (Curb Ramps)

Intersection ID: 48421 Main Street: EVANTON_LOCH_RD Cross Street: CULLEN_CT Location: N ADA ID: EF820AB0B28D Ramp Type: Perp Initial Pass/Fail: Fail Overall Compliance: No Severity Score: 21.25 Codes/Mitigation Info/Possible Solution Possible Solutions: Field Measurements/Component Compliance Data Remove & Replace Entire Ramp. N/A Ramp Length (in) 46.0 No Ramp Slope (%) 9.5 N/A Flare Type LT N/A Flare Type RT N/A N/A Flare Slope LT (%) N/A Flare Slope RT (%) N/A N/A Flare Traversable LT? N/A Flare Traversable RT? N/A
Codes/Mitigation Info/Possible Solution Field Measurements/Component Compliance Possible Solutions: Compliance Description Data Compliance Description Data N/A Ramp Length (in) 46.0 No Ramp Slope (%) 9.5 No Ramp Width (in) 46.0 No Ramp XSlope (%) 1.0 N/A Flare Type LT N/A Flare Type RT N/A N/A Flare Slope LT (%) N/A Flare Slope RT (%) N/A
Possible Solutions: Compliance Description Data Compliance Description Data N/A Ramp Length (in) 46.0 No Ramp Slope (%) 9.5 No Ramp Width (in) 46.0 Yes Ramp XSlope (%) 1.0 N/A Flare Type LT N/A Flare Type RT N/A N/A Flare Slope LT (%) N/A Flare Slope RT (%) N/A

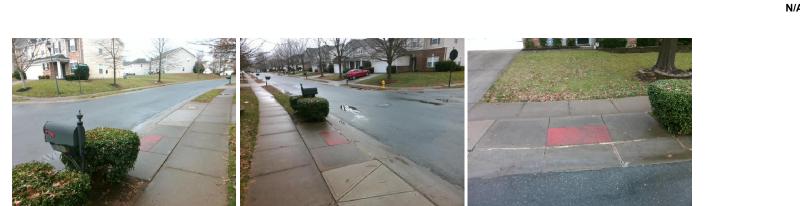
N/ARamp Length (in)46.0NoRamp Slope (%)9.5NoRamp Width (in)46.0YesRamp XSlope (%)1.0N/AFlare Type LTN/AN/AFlare Type RTN/AN/AFlare Slope LT (%)N/AN/AFlare Slope RT (%)N/A
No Ramp Width (in) 46.0 Yes Ramp XSlope (%) 1.0 N/A Flare Type LT N/A N/A Flare Type RT N/A N/A Flare Slope LT (%) N/A Flare Slope RT (%) N/A
N/A Flare Type LT N/A N/A Flare Type RT N/A N/A Flare Slope LT (%) N/A N/A Flare Slope RT (%) N/A
N/A Flare Slope LT (%) N/A Flare Slope RT (%) N/A
N/A Elara Travarsable I T2 N/A N/A Elara Travarsable DT2 N/A
N/A Flate traversable LT? N/A N/A Flate traversable RT? N/A
N/A Landing Length (in) N/A DWS Provided? N/A
Surveyor Notes: N/A Landing Width (in) N/A DWS Contrast? N/A
EVANUOR LOOPL RD N/A N/A N/A Landing Slope (%) N/A DWS Length (in) N/A
N/A Landing X Slope (%) N/A DWS Full Width? N/A
N/A Landing Curb? (Y/N) N/A DWS Offset (in) N/A
N/A Shared Landing? N/A
PROW/ADA: N/A Gutter Ponding? N/A N/A Gutter Slope (%) N/A N/A Gutter Lip Ht (in) N/A Gutter X Slope (%) N/A N/A Painted X Walk1? No N/A Painted X Walk2? N/A

R304.5.1, R304.2.2 N/A Gutter Lip Ht (in) N/A N/A Gutter X Slope (%) N/A
N/A Painted X Walk1? No N/A Painted X Walk2? N/A
X Walk 1 Direction To SW X Walk 2 Direction N/A
N/A X Walk 1 Width (in) N/A N/A X Walk 2 Width (in) N/A
Street 1 Name EVANTON LOCH RD X Walk 1 Slope (%) 2.9 X Walk 2 Slope (%) N/A
Stop Condition-Street 2 None X Walk 1 X Slope (%) 5.1 X Walk 2 X Slope (%) N/A
Street 2 Name N/A N/A Ramp inside XWalk1? N/A N/A Ramp inside XWalk2? N/A
Stop Condition-Street 1 N/A N/A Clear Space? N/A
Road X Slope (%) N/A N/A Clear Space to XWalk (in) N/A
N/A Any Obstructions? N/A N/A Storm Grate/Utility Hazard? N/A
Total Cost: \$ 1850.00 Obstruction Type Storm Grate/Utility Type
N/A N/A
