# Access Compliance Report

## Public Rights-of-Way

### (Curb Ramps)

| Intersection ID: N/A | Main Street: MEADOW_VISTA_RD | Cross Street: OLD_CONCORD_RD | Location: NW |

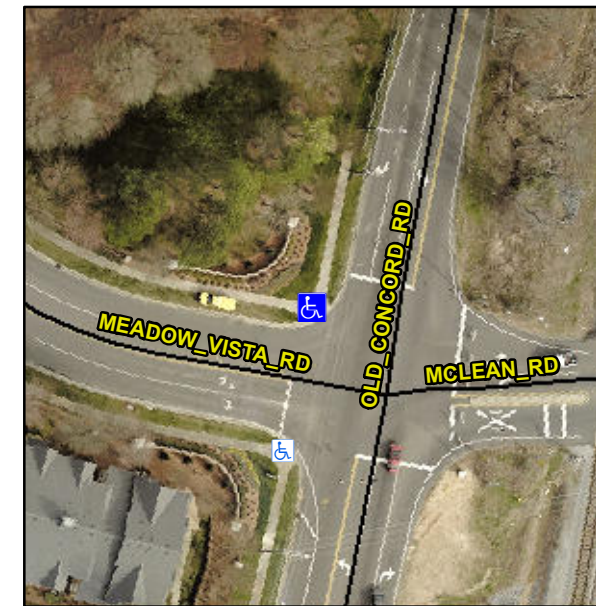
| ADA ID: EF83861876E3 | Ramp Type: PerpDiag | Initial Pass/Fail: Fail | Overall Compliance: No |
| | | Severity Score: 10 | |

| Compliance | Description | Data | Compliance | Description | Data |
|---|---|---|---|---|---|
| N/A | Ramp Length (in) | 42.0 | Yes | Ramp Slope (%) | 5.2 |
| No | Ramp Width (in) | 41.0 | No | Ramp XSlope (%) | 2.5 |

**Remove & Replace Curb Ramp With Two New Directional Ramps or Equivalent.**

**R304.5.1, R304.5.3**
