## Access Compliance Report Public Rights-of-Way (Curb Ramps)

Intersection ID: 25477 Main Street: FIVE\_KNOLLS\_DR Cross Street: REA\_RD Location: NW

ADA ID: EF851540C034 Ramp Type: Directional1 Initial Pass/Fail: Pass Overall Compliance: No Severity Score: 0

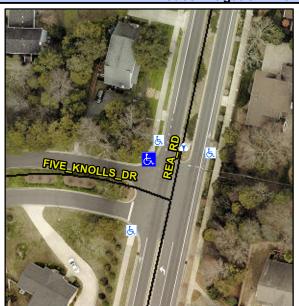
R304.2.1, R304.5.3

| Compliance Description Data Compliance Description Data | | | | | |
|---|---|---|---|---|---|
| Yes | Ramp Width (in) | 68.5 | No | Grade Break Slope (%) | 5.7 |
| No | Landing Length (in) | 38.0 | Yes | DWS Provided? | Yes |

Remove & Replace Entire Ramp.
