# Access Compliance Report

## Public Rights-of-Way

### (Curb Ramps)

Intersection ID: 15932	Main Street: HARTFORD_AV	Cross Street: WESTON_ST	Location: E
ADA ID: EF89D05057A1	Ramp Type: BlendTrans2	Initial Pass/Fail: Fail	Overall Compliance: No
Severity Score: 17.5			
Codes/Mitigation Info/Possible Solution		Field Measurements/Component Compliance

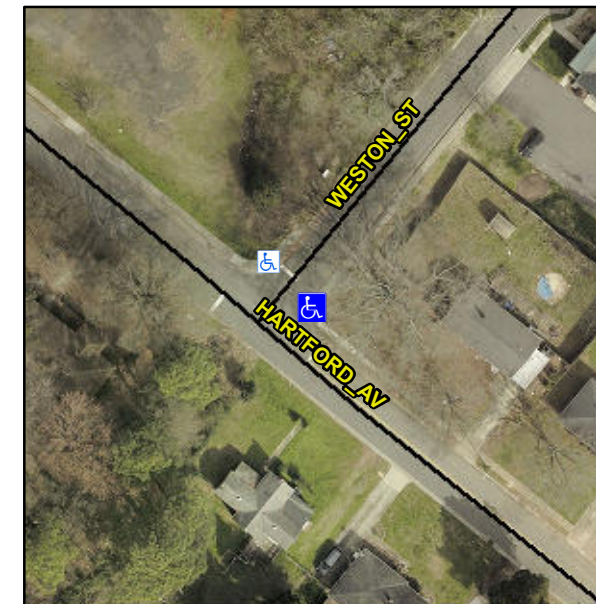
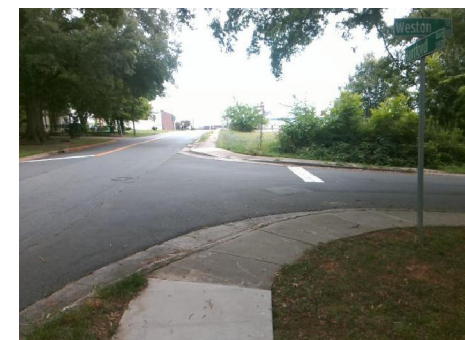
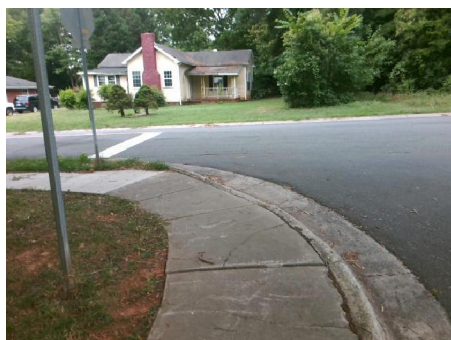
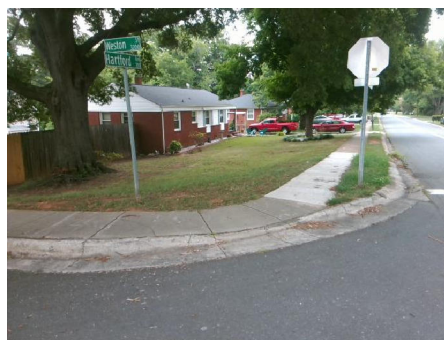
Compliance	Description	Data	Compliance	Description	Data
N/A	Ramp Length (in)	48.0	Yes	BlendTrans Slope (%)	1.9
No	Ramp Width (in)	33.0	Yes	BlendTrans XSlope (%)	1.0
N/A	Flare Type LT	N/A	N/A	Flare Type RT	N/A
N/A	Flare Slope LT (%)	N/A	N/A	Flare Slope RT (%)	N/A
N/A	Flare Traversable LT?	N/A	N/A	Flare Traversable RT?	N/A
N/A	Landing Length (in)	N/A	N/A	DWS Provided?	N/A
N/A	Landing Width (in)	N/A	N/A	DWS Contrast?	N/A
N/A	Landing Slope (%)	N/A	N/A	DWS Length (in)	N/A
N/A	Landing X Slope (%)	N/A	N/A	DWS Full Width?	N/A
N/A	Landing Curb? (Y/N)	N/A	N/A	DWS Offset (in)	N/A
N/A	Shared Landing?	N/A			
N/A	Gutter Ponding?	N/A	N/A	Gutter Slope (%)	N/A
N/A	Gutter Lip Ht (in)	2.0	N/A	Gutter X Slope (%)	N/A
N/A	Painted X Walk1?	No	N/A	Painted X Walk2?	No
	X Walk 1 Direction	To NW		X Walk 2 Direction	To SW
	X Walk 1 Width (in)	N/A		X Walk 2 Width (in)	N/A
	X Walk 1 Slope (%)	3.0		X Walk 2 Slope (%)	0.9
	X Walk 1 X Slope (%)	6.5		X Walk 2 X Slope (%)	3.9

N/A	Ramp inside XWalk1?	N/A	N/A	Ramp inside XWalk2?	N/A
	Road Slope (%)	0.0		Clear Space?	N/A
	Road X Slope (%)	5.9	N/A	Clear Space to XWalk (in)	N/A
N/A	Any Obstructions?	N/A	N/A	Storm Grate/Utility Hazard?	N/A
	Obstruction Type			Storm Grate/Utility Type	
		N/A			N/A
			Yes	Surface Condition? (G/P)	Good
			No	Curb Slope (%)	9.5

Possible Solutions:

**Remove & Replace Curb Ramp With Two New Directional Ramps or Equivalent.**

**Not Found, R304.5.1**
