Access Compliance Report

Public Rights-of-Way

(Curb Ramps)

Intersection ID: 12438	Main Street: E_8TH_ST	Cross Street: N_DAVIDSON_ST	Location: N
ADA ID: EF96335280AD	Ramp Type: PerpDiag	Initial Pass/Fail: Fail	Overall Compliance: No
Severity Score: 8.75			
Codes/Mitigation Info/Possible Solution		Field Measurements/Component Compliance

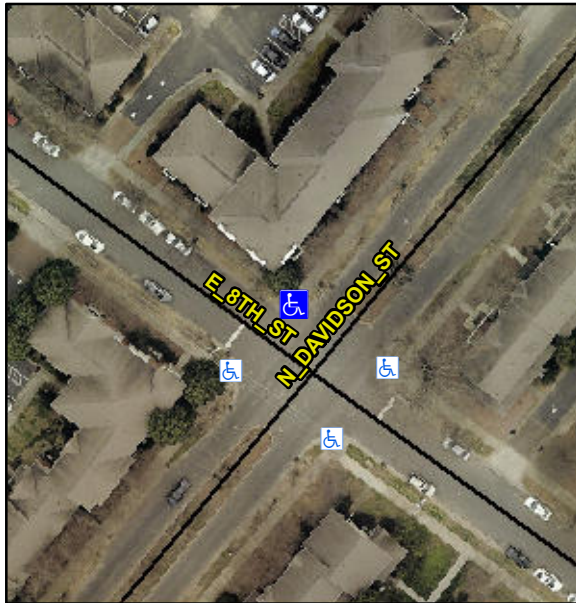
Compliance	Description	Data	Compliance	Description	Data
N/A	Ramp Length (in)	41.0	Yes	Ramp Slope (%)	7.4
No	Ramp Width (in)	43.0	Yes	Ramp XSlope (%)	0.2
N/A	Flare Type LT	N/A	N/A	Flare Type RT	N/A
N/A	Flare Slope LT (%)	N/A	N/A	Flare Slope RT (%)	N/A
N/A	Flare Traversable LT?	N/A	N/A	Flare Traversable RT?	N/A
N/A	Landing Length (in)	N/A	N/A	DWS Provided?	N/A
N/A	Landing Width (in)	N/A	N/A	DWS Contrast?	N/A
N/A	Landing Slope (%)	N/A	N/A	DWS Length (in)	N/A
N/A	Landing X Slope (%)	N/A	N/A	DWS Full Width?	N/A
N/A	Landing Curb? (Y/N)	N/A	N/A	DWS Offset (in)	N/A
N/A	Shared Landing?	N/A			
N/A	Gutter Ponding?	N/A	N/A	Gutter Slope (%)	N/A
N/A	Gutter Lip Ht (in)	0.5	N/A	Gutter X Slope (%)	N/A
N/A	Painted X Walk1?	No	N/A	Painted X Walk2?	No
	X Walk 1 Direction	To SW		X Walk 2 Direction	To SE
N/A	X Walk 1 Width (in)	N/A	N/A	X Walk 2 Width (in)	N/A
	X Walk 1 Slope (%)	1.7		X Walk 2 Slope (%)	0.8
	X Walk 1 X Slope (%)	0.0		X Walk 2 X Slope (%)	1.3

N/A	Ramp inside XWalk1?	N/A	N/A	Ramp inside XWalk2?	N/A
	Road Slope (%)	0.7	N/A	Clear Space?	N/A
	Road X Slope (%)	1.5	N/A	Clear Space to XWalk (in)	N/A
N/A	Any Obstructions?	N/A	N/A	Storm Grate/Utility Hazard?	N/A
	Obstruction Type			Storm Grate/Utility Type	
		N/A			N/A
		Yes		Surface Condition? (G/P)	Good

Possible Solutions:

Remove & Replace Curb Ramp With Two New Directional Ramps or Equivalent.

Not Found, R304.5.1
