# Access Compliance Report

## Public Rights-of-Way

### (Curb Ramps)

Intersection ID: 25024	Main Street: CATHERINE_MILLER_DR	Cross Street: JOSEPH_CLARK_RD	Location: SW
ADA ID: EF9972C0F550	Ramp Type: BlendTrans2	Initial Pass/Fail: Fail	Overall Compliance: No
		Severity Score: 8.75

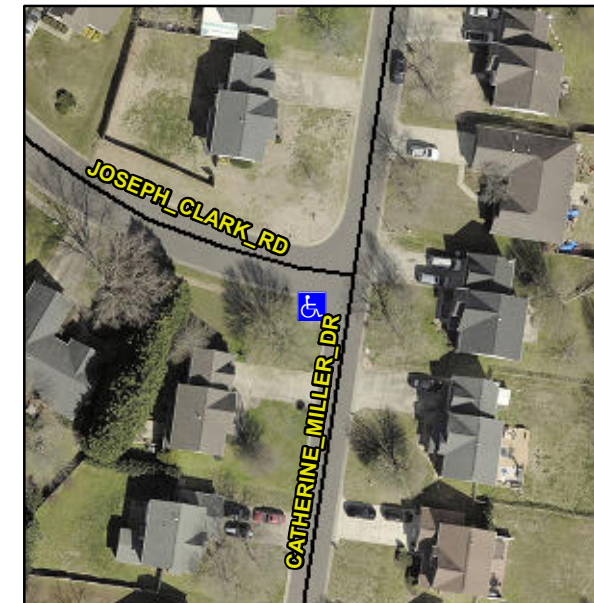
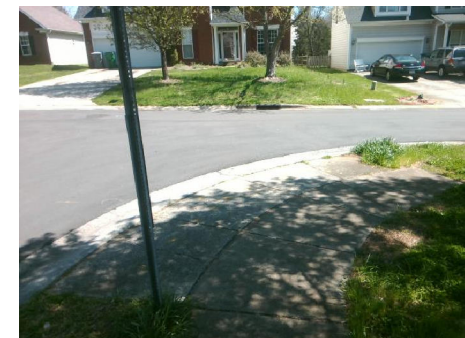
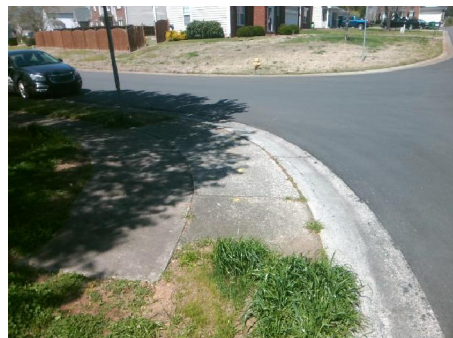
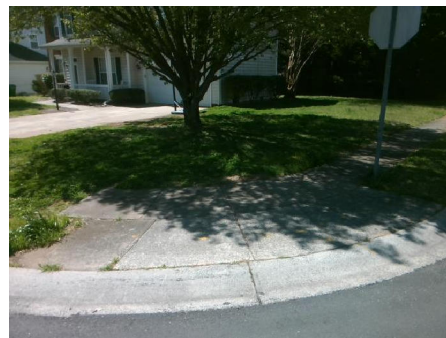
**Not Found, R304.5.1**

Compliance	Description	Data	Compliance	Description	Data
N/A	Ramp Length (in)	96.0	Yes	BlendTrans Slope (%)	2.2
No	Ramp Width (in)	36.0	Yes	BlendTrans XSlope (%)	0.7
N/A	Flare Type LT	N/A	N/A	Flare Type RT	N/A
N/A	Flare Slope LT (%)	N/A	N/A	Flare Slope RT (%)	N/A
N/A	Flare Traversable LT?	N/A	N/A	Flare Traversable RT?	N/A
N/A	Landing Length (in)	N/A	N/A	DWS Provided?	N/A
N/A	Landing Width (in)	N/A	N/A	DWS Contrast?	N/A
N/A	Landing Slope (%)	N/A	N/A	DWS Length (in)	N/A
N/A	Landing X Slope (%)	N/A	N/A	DWS Full Width?	N/A
N/A	Landing Curb? (Y/N)	N/A	N/A	DWS Offset (in)	N/A
N/A	Shared Landing?	N/A			
N/A	Gutter Ponding?	N/A	N/A	Gutter Slope (%)	N/A
N/A	Gutter Lip Ht (in)	N/A	N/A	Gutter X Slope (%)	N/A
N/A	Painted X Walk1?	No	N/A	Painted X Walk2?	No
	X Walk 1 Direction	To E		X Walk 2 Direction	To N
	X Walk 1 Width (in)	N/A		X Walk 2 Width (in)	N/A
	X Walk 1 Slope (%)	0.1		X Walk 2 Slope (%)	3.7
	X Walk 1 X Slope (%)	4.4		X Walk 2 X Slope (%)	1.3

N/A	Ramp inside XWalk1?	N/A	N/A	Ramp inside XWalk2?	N/A
	Road Slope (%)	0.8		Clear Space?	N/A
	Road X Slope (%)	4.6	N/A	Clear Space to XWalk (in)	N/A
N/A	Any Obstructions?	N/A	N/A	Storm Grate/Utility Hazard?	N/A
	Obstruction Type			Storm Grate/Utility Type	
		N/A			N/A
			Yes	Surface Condition? (G/P)	Good
			No	Curb Slope (%)	26.9

**Remove & Replace Curb Ramp With Two New Directional Ramps or Equivalent.**
