# Access Compliance Report

## Public Rights-of-Way

| Intersection ID: 31537 | Main Street: CARLEEN_WAY_DR | Cross Street: GRIER_SPRINGS_LN | Location: W |
| ADA ID: EFA33A6615E3 | Ramp Type: BlendTrans1 | Initial Pass/Fail: Fail | Overall Compliance: No |

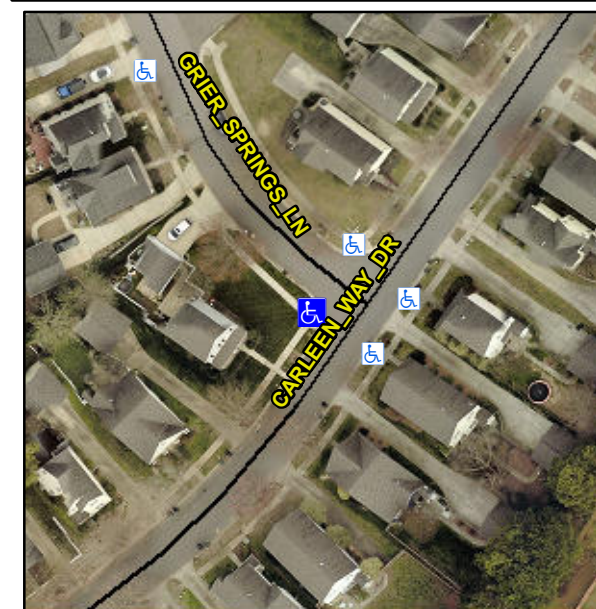
| Severity Score: 17.5 | | | |

| Compliance | Description | Data | Compliance | Description | Data |
|---|---|---|---|---|---|
| No | Ramp Width (in) | 34.0 | Yes | BlendTrans XSlope (%) | 1.6 |

**Remove & Replace Curb Ramp With Two New Directional Ramps or Equivalent.**

**R304.5.1**

Total Cost: \$ 3200.00
