Access Compliance Report

Public Rights-of-Way

(Curb Ramps)

| Intersection ID: 18216 | Main Street: FOREST_DR | Cross Street: S_WENDOVER_RD | Location: SE |

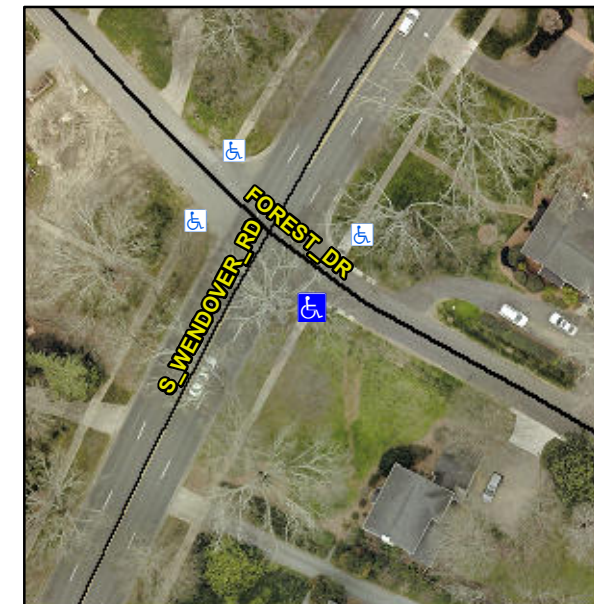
Not Found, R304.5.3

| Compliance | Description | Data | Compliance | Description | Data |
|---|---|---|---|---|---|
| Yes | Ramp Width (in) | 50.0 | No | BlendTrans XSlope (%) | 5.6 |
| | | | No | Curb Slope (%) | 16.8 |

Remove & Replace Curb Ramp With Two New Directional Ramps or Equivalent.
