Access Compliance Report

Public Rights-of-Way

(Curb Ramps)

Intersection ID: 30318	Main Street: CANNONBALL_DR	Cross Street: SHINKANSEN_DR	Location:	N
ADA ID: EFACF72C5FC5	Ramp Type: PerpDiag	Initial Pass/Fail: Fail	Overall Compliance: No	Severity Score: 10

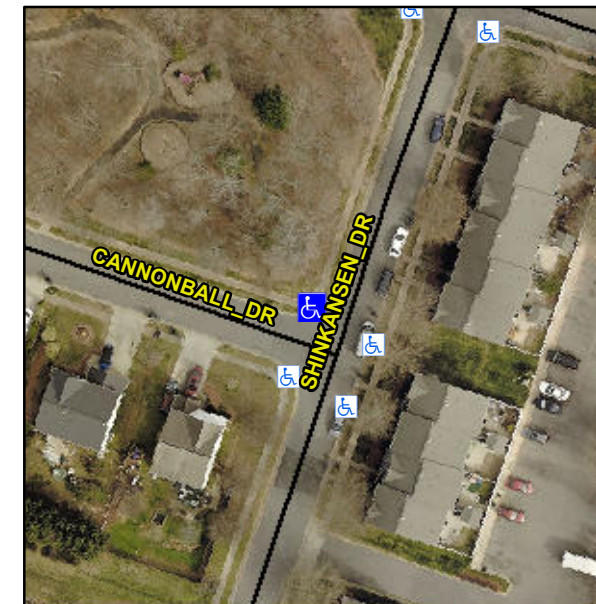
Not Found, R304.5.1, R304.5.3

Compliance	Description	Data	Compliance	Description	Data
N/A	Ramp Length (in)	44.5	Yes	Ramp Slope (%)	5.3
No	Ramp Width (in)	42.0	No	Ramp XSlope (%)	4.0
N/A	Flare Type LT	N/A	N/A	Flare Type RT	N/A
N/A	Flare Slope LT (%)	N/A	N/A	Flare Slope RT (%)	N/A
N/A	Flare Traversable LT?	N/A	N/A	Flare Traversable RT?	N/A
N/A	Landing Length (in)	N/A	N/A	DWS Provided?	N/A
N/A	Landing Width (in)	N/A	N/A	DWS Contrast?	N/A
N/A	Landing Slope (%)	N/A	N/A	DWS Length (in)	N/A
N/A	Landing X Slope (%)	N/A	N/A	DWS Full Width?	N/A
N/A	Landing Curb? (Y/N)	N/A	N/A	DWS Offset (in)	N/A
N/A	Shared Landing?	N/A			
N/A	Gutter Ponding?	N/A	N/A	Gutter Slope (%)	N/A
N/A	Gutter Lip Ht (in)	N/A	N/A	Gutter X Slope (%)	N/A
N/A	Painted X Walk1?	No	N/A	Painted X Walk2?	No
	X Walk 1 Direction	To SW		X Walk 2 Direction	To SE
N/A	X Walk 1 Width (in)	N/A	N/A	X Walk 2 Width (in)	N/A
	X Walk 1 Slope (%)	2.5		X Walk 2 Slope (%)	6.3
	X Walk 1 X Slope (%)	6.6		X Walk 2 X Slope (%)	0.5

N/A	Ramp inside XWalk1?	N/A	N/A	Ramp inside XWalk2?	N/A
	Road Slope (%)	2.9	N/A	Clear Space?	N/A
	Road X Slope (%)	7.1	N/A	Clear Space to XWalk (in)	N/A
N/A	Any Obstructions?	N/A	N/A	Storm Grate/Utility Hazard?	N/A
	Obstruction Type			Storm Grate/Utility Type	
		N/A			N/A
			Yes	Surface Condition? (G/P)	Good

Remove & Replace Curb Ramp With Two New Directional Ramps or Equivalent.

Total Cost: \$ 3200.00
