Access Compliance Report Public Rights-of-Way (Curb Ramps)

| Intersection ID: 20640 | Main Street: S_TRYON_ST | | | troot | VAGER CREEK DP | Location: | w | | | |
| | | | | Cross Street: YAGER_CREEK_DR | | | | | | |
| ADA ID: EFB17C19AC69 Ramp Type: Perp | | | Initial Pass/Fail: Fail Overall Compliance: No | | | | o Severity Score: | 21.25 | | |

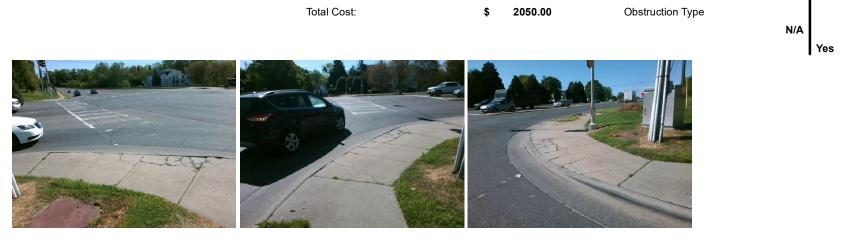
| Intersection ID: 20640 | Main Street: S_TRYON_ST | | | troot | VAGER CREEK DP | Location: | w | | | |
|--|---|--|--|---|---|---|---|---|---|--|
| CONTRACT OF | 3/3/1/2 | Remove & Replace Entire Ram Restripe Crosswalk. | | N/A | Ramp Length (in) | 72.0 | No | Ramp Slope (%) | 8.9 | |
| | | | | No | Ramp Width (in) | 41.0 | Yes | Ramp XSlope (%) | 2.0 | |
| | all the second | Not Found, R304.5.1, R304.2.2 | | N/A | Gutter Lip Ht (in) | N/A | N/A | Gutter X Slope (%) | N/A | |
| Street 2 Name | N/A | | | N/A | Ramp inside XWalk1? | No | N/A | Ramp inside XWalk2? | N/A | |

| Intersection ID: 20640 | Main Street: S_TRYON_ST | | | troot | VAGER CREEK DP | Location: | w | | | |
|--|---|--|--|---|---|---|---|---|---|--|
| | | Total Cost: \$ | 2050.00 | | Obstruction Type | | | Storm Grate/Utility Type | | |
