Access Compliance Report

Public Rights-of-Way

(Curb Ramps)

Intersection ID: N/A	Main Street: E_4TH_ST	Cross Street: S_CALDWELL_ST	Location: N
ADA ID: EFC06CFF0698	Ramp Type: Perp	Initial Pass/Fail: Fail	Overall Compliance: No
		Severity Score: 1.25

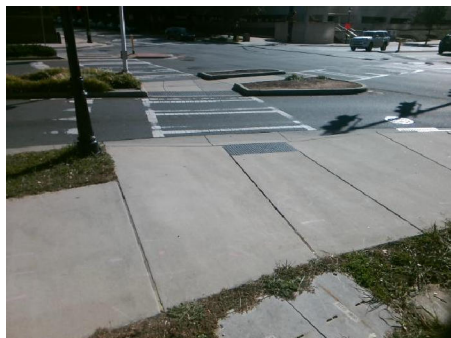
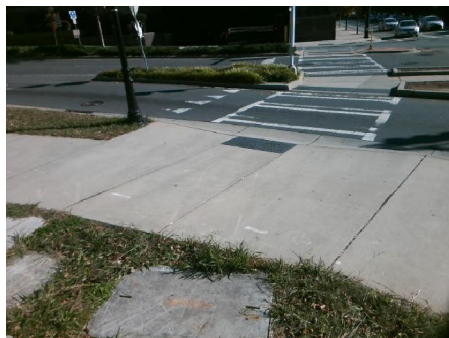
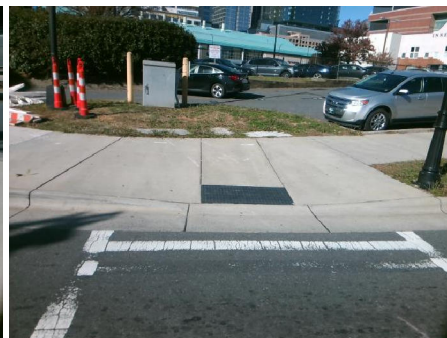
Not Found, R304.5.3

Compliance	Description	Data	Compliance	Description	Data
N/A	Ramp Length (in)	141.0	Yes	Ramp Slope (%)	5.8
Yes	Ramp Width (in)	49.0	No	Ramp XSlope (%)	3.0
N/A	Flare Type LT	N/A	N/A	Flare Type RT	N/A
N/A	Flare Slope LT (%)	N/A	N/A	Flare Slope RT (%)	N/A
N/A	Flare Traversable LT?	No	N/A	Flare Traversable RT?	No
N/A	Landing Length (in)	N/A	N/A	DWS Provided?	N/A
N/A	Landing Width (in)	N/A	N/A	DWS Contrast?	N/A
N/A	Landing Slope (%)	N/A	N/A	DWS Length (in)	N/A
N/A	Landing X Slope (%)	N/A	N/A	DWS Full Width?	N/A
N/A	Landing Curb? (Y/N)	N/A	N/A	DWS Offset (in)	N/A
N/A	Shared Landing?	N/A			
N/A	Gutter Ponding?	N/A	N/A	Gutter Slope (%)	N/A
N/A	Gutter Lip Ht (in)	N/A	N/A	Gutter X Slope (%)	N/A
N/A	Painted X Walk1?	Yes	N/A	Painted X Walk2?	N/A
	X Walk 1 Direction	To S		X Walk 2 Direction	N/A
N/A	X Walk 1 Width (in)	120.0	N/A	X Walk 2 Width (in)	N/A
	X Walk 1 Slope (%)	0.7		X Walk 2 Slope (%)	N/A
	X Walk 1 X Slope (%)	1.5		X Walk 2 X Slope (%)	N/A

N/A	Ramp inside XWalk1?	Yes	N/A	Ramp inside XWalk2?	N/A
	Road Slope (%)	N/A	N/A	Clear Space?	N/A
	Road X Slope (%)	N/A	N/A	Clear Space to XWalk (in)	N/A
N/A	Any Obstructions?	N/A	N/A	Storm Grate/Utility Hazard?	N/A
	Obstruction Type			Storm Grate/Utility Type	
		N/A			N/A
			Yes	Surface Condition? (G/P)	Good

Remove & Replace Entire Ramp.
