# Access Compliance Report

## Public Rights-of-Way

### (Curb Ramps)

Intersection ID: 30179	Main Street: FAIRSTONE_AV	Cross Street: VECKMAN_CT	Location: NW
ADA ID: EFC22DD66E51	Ramp Type: PerpDiag	Initial Pass/Fail: Pass	Overall Compliance: No
Severity Score: 7.75			
Codes/Mitigation Info/Possible Solution		Field Measurements/Component Compliance

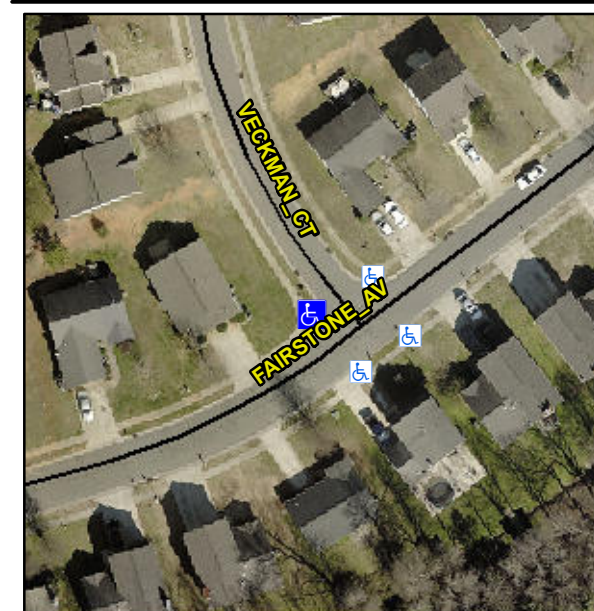
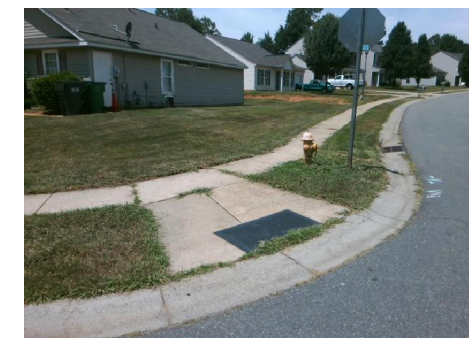
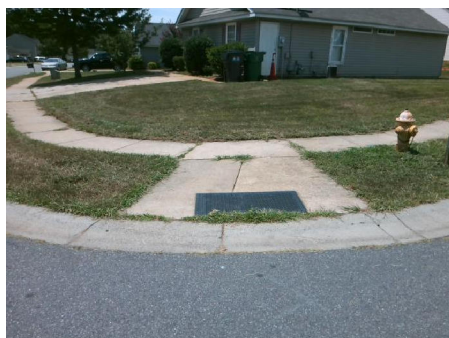
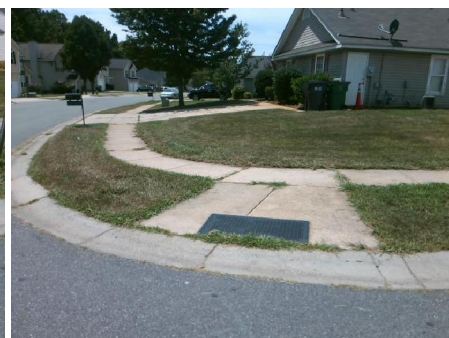
**Not Found, R304.5.3, R304.2.1, R305.1.4, R304.5.4**

Compliance	Description	Data	Compliance	Description	Data
N/A	Ramp Length (in)	80.0	Yes	Ramp Slope (%)	5.1
Yes	Ramp Width (in)	50.0	No	Ramp XSlope (%)	2.1
N/A	Flare Type LT	Sloped	N/A	Flare Type RT	N/A
N/A	Flare Slope LT (%)	1.5	N/A	Flare Slope RT (%)	3.7
N/A	Flare Traversable LT?	No	N/A	Flare Traversable RT?	No
No	Landing Length (in)	45.0	Yes	DWS Provided?	Yes
Yes	Landing Width (in)	64.0	Yes	DWS Contrast?	Yes
Yes	Landing Slope (%)	2.0	Yes	DWS Length (in)	25.5
No	Landing X Slope (%)	2.6	No	DWS Full Width?	No
N/A	Landing Curb? (Y/N)	No	Yes	DWS Offset (in)	2.0
N/A	Shared Landing?	No			
Yes	Gutter Ponding?	No	No	Gutter Slope (%)	5.6
Yes	Gutter Lip Ht (in)	0.0	Yes	Gutter X Slope (%)	0.8
N/A	Painted X Walk1?	No	N/A	Painted X Walk2?	No
	X Walk 1 Direction	To S		X Walk 2 Direction	To NE
N/A	X Walk 1 Width (in)	N/A	N/A	X Walk 2 Width (in)	N/A
	X Walk 1 Slope (%)	2.6		X Walk 2 Slope (%)	4.7
	X Walk 1 X Slope (%)	2.9		X Walk 2 X Slope (%)	1.1

N/A	Ramp inside XWalk1?	N/A	N/A	Ramp inside XWalk2?	N/A
	Road Slope (%)	1.5	N/A	Clear Space?	Yes
	Road X Slope (%)	3.0	N/A	Clear Space to XWalk (in)	N/A
Yes	Any Obstructions?	No	Yes	Storm Grate/Utility Hazard?	No
	Obstruction Type			Storm Grate/Utility Type	
		N/A			N/A
		Yes	Yes	Surface Condition? (G/P)	Good

Possible Solutions:

**Remove & Replace Curb Ramp With Two New Directional Ramps or Equivalent. Remove & Replace Gutter.**

Total Cost: \$ 3950.00
