# Access Compliance Report

## Public Rights-of-Way

### (Curb Ramps)

Intersection ID: 15363	Main Street: CUMBERLAND_AV	Cross Street: EAST_BV	Location: S
ADA ID: EFC4FCDECE43	Ramp Type: PerpDiag	Initial Pass/Fail: Fail	Overall Compliance: No
Codes/Mitigation Info/Possible Solution		Field Measurements/Component Compliance	
Severity Score: 21.25

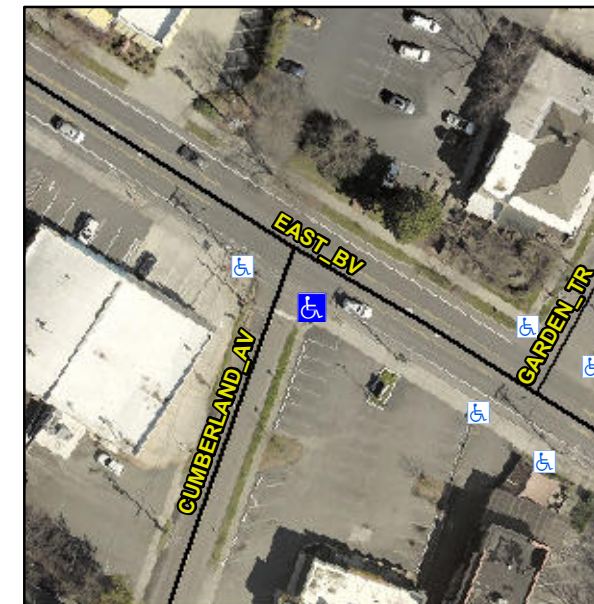
**Not Found, R304.5.1, R304.2.2**

Compliance	Description	Data	Compliance	Description	Data
N/A	Ramp Length (in)	49.0	No	Ramp Slope (%)	9.1
No	Ramp Width (in)	43.0	Yes	Ramp XSlope (%)	0.1
N/A	Flare Type LT	N/A	N/A	Flare Type RT	N/A
N/A	Flare Slope LT (%)	N/A	N/A	Flare Slope RT (%)	N/A
N/A	Flare Traversable LT?	N/A	N/A	Flare Traversable RT?	N/A
N/A	Landing Length (in)	N/A	N/A	DWS Provided?	N/A
N/A	Landing Width (in)	N/A	N/A	DWS Contrast?	N/A
N/A	Landing Slope (%)	N/A	N/A	DWS Length (in)	N/A
N/A	Landing X Slope (%)	N/A	N/A	DWS Full Width?	N/A
N/A	Landing Curb? (Y/N)	N/A	N/A	DWS Offset (in)	N/A
N/A	Shared Landing?	N/A			
N/A	Gutter Ponding?	N/A	N/A	Gutter Slope (%)	N/A
N/A	Gutter Lip Ht (in)	N/A	N/A	Gutter X Slope (%)	N/A
N/A	Painted X Walk1?	No	N/A	Painted X Walk2?	No
	X Walk 1 Direction	To NE		X Walk 2 Direction	To NW
N/A	X Walk 1 Width (in)	N/A	N/A	X Walk 2 Width (in)	N/A
	X Walk 1 Slope (%)	5.2		X Walk 2 Slope (%)	7.6
	X Walk 1 X Slope (%)	5.3		X Walk 2 X Slope (%)	4.0

N/A	Ramp inside XWalk1?	N/A	N/A	Ramp inside XWalk2?	N/A
	Road Slope (%)	1.0	N/A	Clear Space?	N/A
	Road X Slope (%)	9.9	N/A	Clear Space to XWalk (in)	N/A
N/A	Any Obstructions?	N/A	N/A	Storm Grate/Utility Hazard?	N/A
	Obstruction Type			Storm Grate/Utility Type	
		N/A			N/A
		Yes		Surface Condition? (G/P)	Good

**Remove & Replace Curb Ramp With Two New Directional Ramps or Equivalent.**
