# Access Compliance Report

## Public Rights-of-Way

### (Curb Ramps)

Intersection ID: 10027410	Main Street: GOLF_ACRES_DR	Cross Street: N/A	Location: NE
ADA ID: EFC99685C4D5	Ramp Type: PerpDiag	Initial Pass/Fail: Fail	Overall Compliance: No
		Severity Score: 25

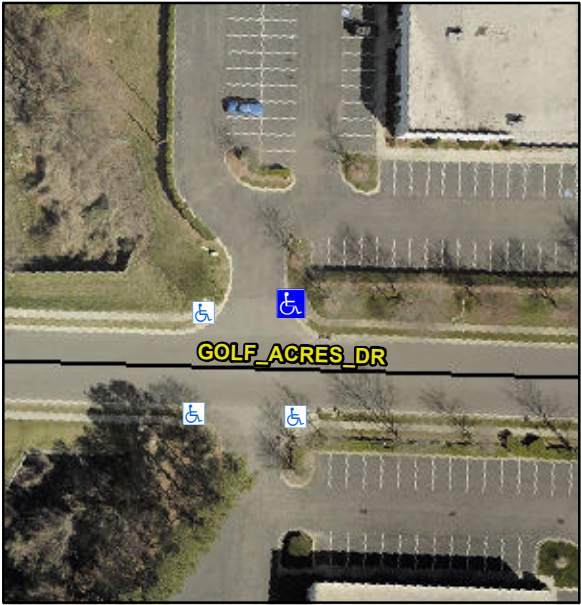
Possible Solutions:		<b>Compliance</b>	<b>Description</b>	<b>Data</b>
	<b>Remove &amp; Replace Curb Ramp With Two New Directional Ramps or Equivalent.</b>		<b>Yes</b>	Ramp Length (in)	<b>103.0</b>
			<b>N/A</b>	Ramp Width (in)	<b>48.0</b>
			<b>N/A</b>	Flare Type LT	<b>N/A</b>
			<b>N/A</b>	Flare Slope LT (%)	<b>N/A</b>
			<b>N/A</b>	Flare Traversable LT?	<b>N/A</b>
			<b>N/A</b>	Flare Type RT	<b>N/A</b>
			<b>N/A</b>	Flare Slope RT (%)	<b>N/A</b>
			<b>N/A</b>	Flare Traversable RT?	<b>N/A</b>
			<b>N/A</b>	DWS Provided?	<b>N/A</b>
			<b>N/A</b>	DWS Contrast?	<b>N/A</b>
			<b>N/A</b>	DWS Length (in)	<b>N/A</b>
			<b>N/A</b>	DWS Full Width?	<b>N/A</b>
			<b>N/A</b>	DWS Offset (in)	<b>N/A</b>
			<b>N/A</b>	Gutter Slope (%)	<b>N/A</b>
			<b>N/A</b>	Gutter X Slope (%)	<b>N/A</b>
			<b>N/A</b>	Painted X Walk1?	<b>No</b>
			<b>N/A</b>	X Walk 1 Direction	<b>To W</b>

<b>N/A</b>	X Walk 2 Direction	<b>To S</b>
			<b>N/A</b>	X Walk 1 Width (in)	<b>N/A</b>
			<b>N/A</b>	X Walk 2 Width (in)	<b>N/A</b>
			<b>N/A</b>	X Walk 1 Slope (%)	<b>2.8</b>
			<b>N/A</b>	X Walk 2 Slope (%)	<b>3.6</b>
			<b>N/A</b>	X Walk 1 X Slope (%)	<b>5.3</b>
			<b>N/A</b>	X Walk 2 X Slope (%)	<b>1.7</b>
			<b>N/A</b>	Ramp inside XWalk1?	<b>N/A</b>
			<b>N/A</b>	Ramp inside XWalk2?	<b>N/A</b>
			<b>N/A</b>	Road Slope (%)	<b>3.6</b>
			<b>N/A</b>	Clear Space?	<b>N/A</b>
			<b>N/A</b>	Road X Slope (%)	<b>0.3</b>
			<b>N/A</b>	Clear Space to XWalk (in)	<b>N/A</b>
			<b>N/A</b>	Any Obstructions?	<b>N/A</b>
			<b>N/A</b>	Obstruction Type	<b>N/A</b>
			<b>N/A</b>	Storm Grate/Utility Hazard?	<b>N/A</b>
			<b>N/A</b>	Storm Grate/Utility Type	<b>N/A</b>
			<b>N/A</b>	Surface Condition? (G/P)	<b>Good</b>

PROW/ADA:

**Not Found, R304.5.3**

Possible Solutions:

**Remove & Replace Curb Ramp With Two New Directional Ramps or Equivalent.**

Total Cost: \$ 3200.00
