# Access Compliance Report

## Public Rights-of-Way

### (Curb Ramps)

| Intersection ID: 28277 | Main Street: EASTON GREY LN | Cross Street: PEMSWOOD ST | Location: NW |

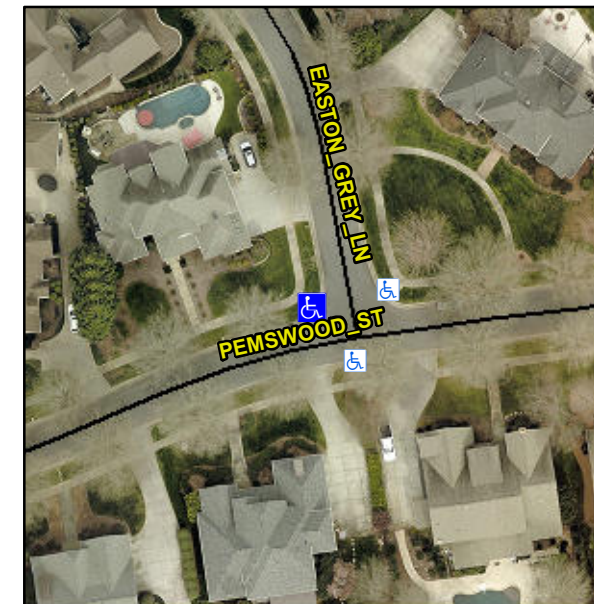
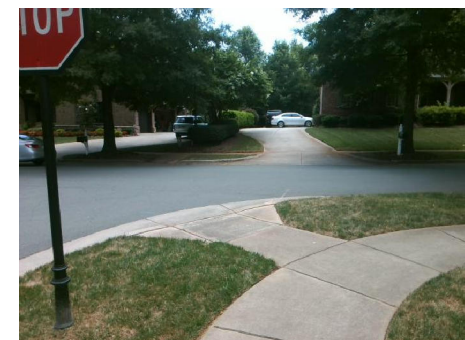
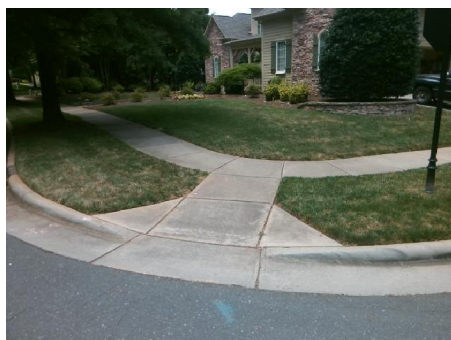
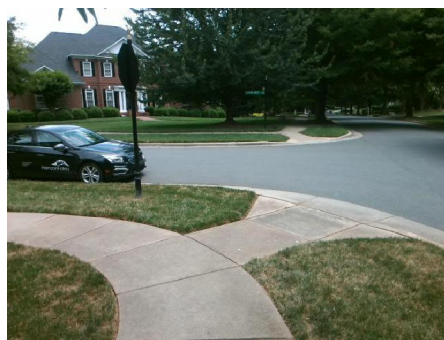
| ADA ID: EFCAE32A38D8 | Ramp Type: BlendTrans2 | Initial Pass/Fail: Fail | Overall Compliance: No |

**R304.5.1, R304.5.3**

| Compliance | Description | Data | Compliance | Description | Data |
|---|---|---|---|---|---|
| No | Ramp Width (in) | 39.0 | No | BlendTrans XSlope (%) | 2.2 |

**Remove & Replace Curb Ramp With Two New Directional Ramps or Equivalent.**
