Intersection ID: 13369	Main Street: N_I-77_RA	Cross Street: WEST_BV	Location:	SW
ADA ID: EFD2C589D049	Ramp Type: ParaDiag	Initial Pass/Fail: Fail	Overall Compliance: No	Severity Score: 13.75

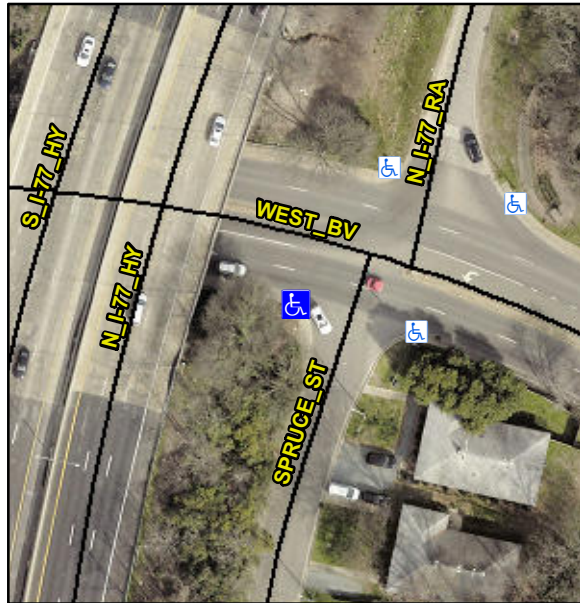
R304.5.3, R304.3.2

Compliance	Description	Data	Compliance	Description	Data
N/A	Ramp Length LT (in)	64.0	N/A	Ramp Length RT (in)	60.0
Yes	Ramp Width LT (in)	50.0	Yes	Ramp Width RT (in)	48.0
Yes	Ramp Slope LT (%)	8.1	No	Ramp Slope RT (%)	8.8
No	Ramp XSlope LT (%)	2.7	No	Ramp XSlope RT (%)	2.8
N/A	Landing Length (in)	N/A	N/A	DWS Provided?	N/A
N/A	Landing Width (in)	N/A	N/A	DWS Contrast?	N/A
N/A	Landing Slope (%)	N/A	N/A	DWS Length (in)	N/A
N/A	Landing X Slope (%)	N/A	N/A	DWS Full Width?	N/A
N/A	Landing Curb? (Y/N)	N/A	N/A	DWS Offset (in)	N/A
N/A	Shared Landing?	N/A			
N/A	Gutter Ponding?	N/A	N/A	Gutter Slope (%)	N/A
N/A	Gutter Lip Ht (in)	N/A	N/A	Gutter X Slope (%)	N/A
N/A	Painted X Walk1?	No	N/A	Painted X Walk2?	No
	X Walk 1 Direction	To SE		X Walk 2 Direction	To NE
N/A	X Walk 1 Width (in)	N/A	N/A	X Walk 2 Width (in)	N/A
	X Walk 1 Slope (%)	2.1		X Walk 2 Slope (%)	3.4
	X Walk 1 X Slope (%)	1.5		X Walk 2 X Slope (%)	0.1
N/A	Ramp inside XWalk1?	N/A	N/A	Ramp inside XWalk2?	N/A

Road Slope (%)	0.8	N/A	Clear Space?	N/A
	Road X Slope (%)	1.5	N/A	Clear Space to XWalk (in)	N/A
N/A	Any Obstructions?	N/A	N/A	Storm Grate/Utility Hazard?	N/A
	Obstruction Type			Storm Grate/Utility Type	
		N/A			N/A
			Yes	Surface Condition? (G/P)	Good
			N/A	Curb Slope (%)	3.6

Remove & Replace Curb Ramp With Two New Directional Ramps or Equivalent.
