# Access Compliance Report

## Public Rights-of-Way

| Intersection ID: 9555 | Main Street: FARRIOR_DR | Cross Street: VICKERY_DR | Location: SE |
| ADA ID: EFD4DEAB823B | Ramp Type: BlendTrans2 | Initial Pass/Fail: Pass | Overall Compliance: No |

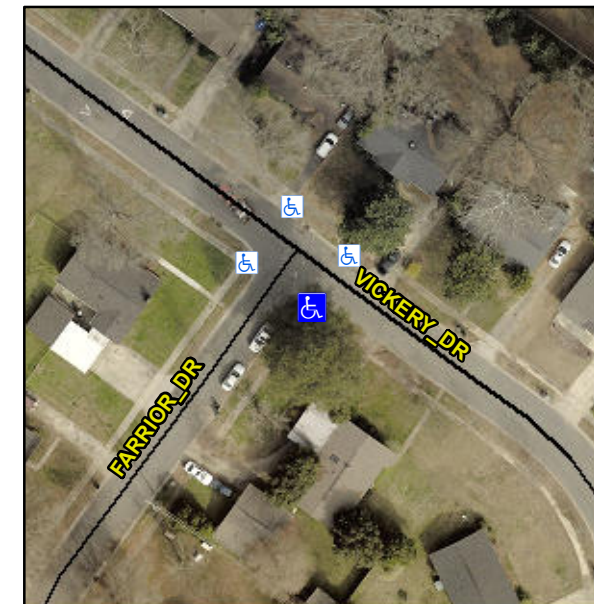
**Not Found, R304.5.3, R305, R302.7, R302.7.2**

| Compliance | Description | Data | Compliance | Description | Data |
|---|---|---|---|---|---|
| Yes | Ramp Width (in) | 48.0 | No | BlendTrans XSlope (%) | 3.7 |
| N/A | Landing Length (in) | N/A | No | DWS Provided? | No |
| No | Gutter Ponding? | Yes | Yes | Gutter Slope (%) | 0.6 |
| No | Gutter Lip Ht (in) | 2.0 | No | Gutter X Slope (%) | 2.2 |
| | | | No | Curb Slope (%) | 19.6 |

**Remove & Replace Curb Ramp With Two New Directional Ramps or Equivalent. Remove & Replace Gutter.**
