# Access Compliance Report

## Public Rights-of-Way

### (Curb Ramps)

| Intersection ID: 23427 | Main Street: GRUENEWALD_LN | Cross Street: OBERBECK_LN | Location: E |

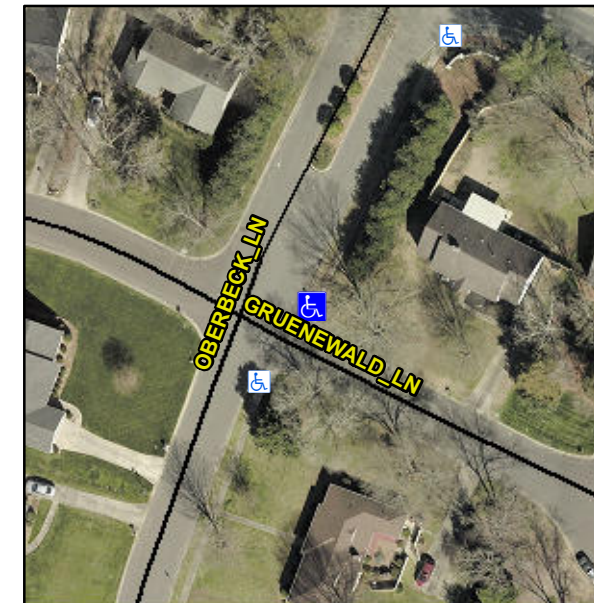
**Not Found, R304.5.1, R304.5.3**

| Compliance | Description | Data | Compliance | Description | Data |
|---|---|---|---|---|---|
| No | Ramp Width (in) | 46.0 | No | BlendTrans XSlope (%) | 2.5 |
| | | | No | Curb Slope (%) | 10.5 |

**Remove & Replace Curb Ramp With Two New Directional Ramps or Equivalent.**

Total Cost: \$ 3200.00

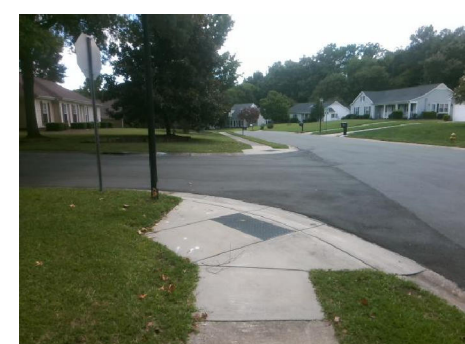
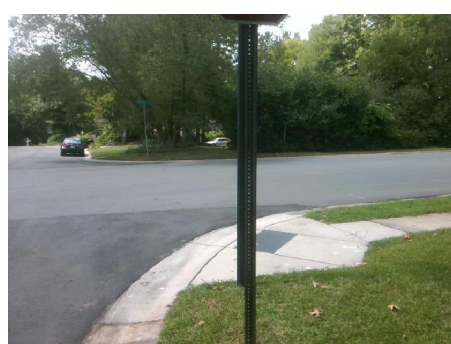
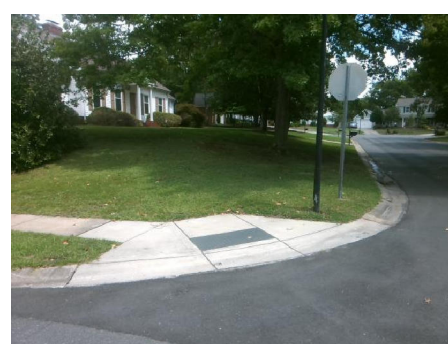
Street 1 Name **OBERBECK LN**  
 Stop Condition-Street 1 **None**  
 Street 2 Name **GRUENEWALD LN**  
 Stop Condition-Street 2 **StopSign**
