# Access Compliance Report

## Public Rights-of-Way

### (Curb Ramps)

Intersection ID: 14652	Main Street: DRIFTWOOD_DR	Cross Street: MCMANUS_DR	Location: NW
ADA ID: EFE520AE6C66	Ramp Type: BlendTrans1	Initial Pass/Fail: Fail	Overall Compliance: No
		Severity Score: 10

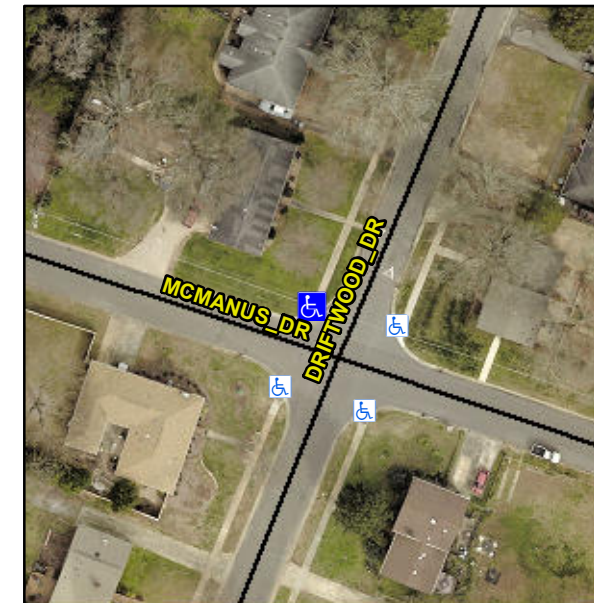
**Not Found, R304.5.1, R304.5.3**

Compliance	Description	Data	Compliance	Description	Data
N/A	Ramp Length (in)	94.0	Yes	BlendTrans Slope (%)	3.5
No	Ramp Width (in)	47.5	No	BlendTrans XSlope (%)	4.7
N/A	Flare Type LT	N/A	N/A	Flare Type RT	N/A
N/A	Flare Slope LT (%)	N/A	N/A	Flare Slope RT (%)	N/A
N/A	Flare Traversable LT?	N/A	N/A	Flare Traversable RT?	N/A
N/A	Landing Length (in)	N/A	N/A	DWS Provided?	N/A
N/A	Landing Width (in)	N/A	N/A	DWS Contrast?	N/A
N/A	Landing Slope (%)	N/A	N/A	DWS Length (in)	N/A
N/A	Landing X Slope (%)	N/A	N/A	DWS Full Width?	N/A
N/A	Landing Curb? (Y/N)	N/A	N/A	DWS Offset (in)	N/A
N/A	Shared Landing?	N/A			
N/A	Gutter Ponding?	Yes	N/A	Gutter Slope (%)	N/A
N/A	Gutter Lip Ht (in)	N/A	N/A	Gutter X Slope (%)	N/A
N/A	Painted X Walk1?	No	N/A	Painted X Walk2?	N/A
	X Walk 1 Direction	To SW		X Walk 2 Direction	N/A
	X Walk 1 Width (in)	N/A		X Walk 2 Width (in)	N/A
	X Walk 1 Slope (%)	3.8		X Walk 2 Slope (%)	N/A
	X Walk 1 X Slope (%)	1.8		X Walk 2 X Slope (%)	N/A

N/A	Ramp inside XWalk1?	N/A	N/A	Ramp inside XWalk2?	N/A
	Road Slope (%)	1.8		Clear Space?	N/A
	Road X Slope (%)	3.8	N/A	Clear Space to XWalk (in)	N/A
N/A	Any Obstructions?	N/A	N/A	Storm Grate/Utility Hazard?	N/A
	Obstruction Type			Storm Grate/Utility Type	
		N/A			N/A
			Yes	Surface Condition? (G/P)	Good
			No	Curb Slope (%)	10.9

**Remove & Replace Curb Ramp With Two New Directional Ramps or Equivalent.**
