Access Compliance Report

Public Rights-of-Way

(Curb Ramps)

Intersection ID: 49255	Main Street: HOPKINS_ST	Cross Street: OAKBURN_DR	Location: SW
ADA ID: EFE96824ACD7	Ramp Type: PerpDiag	Initial Pass/Fail: Fail	Overall Compliance: No
Severity Score: 8.75			
Codes/Mitigation Info/Possible Solution		Field Measurements/Component Compliance

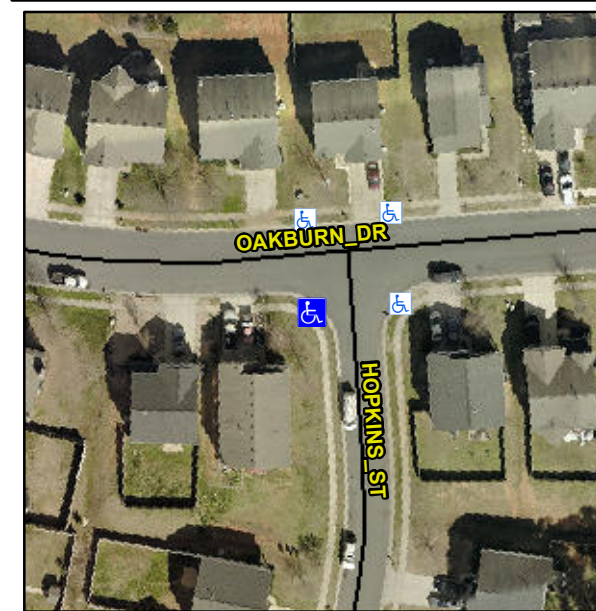
Not Found, R304.5.1

Compliance	Description	Data	Compliance	Description	Data
N/A	Ramp Length (in)	47.0	Yes	Ramp Slope (%)	6.6
No	Ramp Width (in)	42.5	Yes	Ramp XSlope (%)	1.9
N/A	Flare Type LT	N/A	N/A	Flare Type RT	N/A
N/A	Flare Slope LT (%)	N/A	N/A	Flare Slope RT (%)	N/A
N/A	Flare Traversable LT?	N/A	N/A	Flare Traversable RT?	N/A
N/A	Landing Length (in)	N/A	N/A	DWS Provided?	N/A
N/A	Landing Width (in)	N/A	N/A	DWS Contrast?	N/A
N/A	Landing Slope (%)	N/A	N/A	DWS Length (in)	N/A
N/A	Landing X Slope (%)	N/A	N/A	DWS Full Width?	N/A
N/A	Landing Curb? (Y/N)	N/A	N/A	DWS Offset (in)	N/A
N/A	Shared Landing?	N/A			
N/A	Gutter Ponding?	N/A	N/A	Gutter Slope (%)	N/A
N/A	Gutter Lip Ht (in)	N/A	N/A	Gutter X Slope (%)	N/A
N/A	Painted X Walk1?	No	N/A	Painted X Walk2?	No
	X Walk 1 Direction	To E		X Walk 2 Direction	To N
N/A	X Walk 1 Width (in)	N/A	N/A	X Walk 2 Width (in)	N/A
	X Walk 1 Slope (%)	0.8		X Walk 2 Slope (%)	1.4
	X Walk 1 X Slope (%)	4.4		X Walk 2 X Slope (%)	0.3

N/A	Ramp inside XWalk1?	N/A	N/A	Ramp inside XWalk2?	N/A
	Road Slope (%)	2.5	N/A	Clear Space?	N/A
	Road X Slope (%)	1.5	N/A	Clear Space to XWalk (in)	N/A
N/A	Any Obstructions?	N/A	N/A	Storm Grate/Utility Hazard?	N/A
	Obstruction Type			Storm Grate/Utility Type	
		N/A			N/A
		Yes		Surface Condition? (G/P)	Good

Remove & Replace Curb Ramp With Two New Directional Ramps or Equivalent.
