Access Compliance Report Public Rights-of-Way (Curb Ramps)

Intersection ID: 10022558 Main Street: CARMEL COMMONS BV Cross Street: N/A SW Location: Initial Pass/Fail: Fail **Overall Compliance: No Severity Score:** ADA ID: EFF3E2F13C33 Ramp Type: PerpDiag 67.5

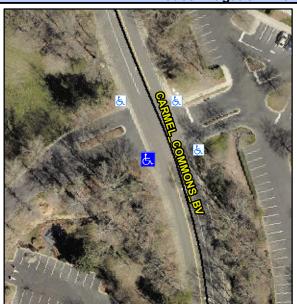
Not Found, R304.5.1, R304.2.2, R304.5.3

CARMEL COMMONS BV Street 1 Name Stop Condition-Street 2 None **ENTRANCE** Street 2 Name Stop Condition-Street 1 StopSign Possible Solutions: Remove & Replace Curb Ramp With Two New Directional Ramps or Equivalent. Surveyor Notes:
