Access Compliance Report

Public Rights-of-Way

(Curb Ramps)

Intersection ID: 3145	Main Street: BASKERVILLE_AV	Cross Street: PALLADIUM_PL	Location: S
ADA ID: EFF7BC50E8BA	Ramp Type: Perp	Initial Pass/Fail: Fail	Overall Compliance: No
Severity Score: 12.5			
Codes/Mitigation Info/Possible Solution		Field Measurements/Component Compliance

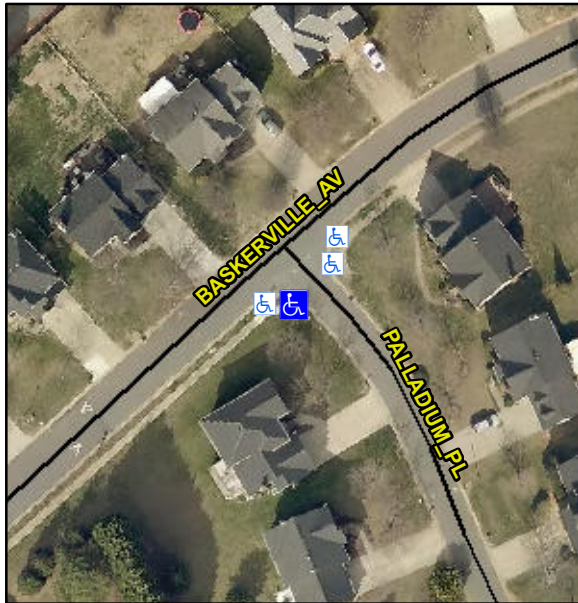
Not Found, R304.2.2

Compliance	Description	Data	Compliance	Description	Data
N/A	Ramp Length (in)	44.0	No	Ramp Slope (%)	9.1
Yes	Ramp Width (in)	67.0	Yes	Ramp XSlope (%)	0.5
N/A	Flare Type LT	N/A	N/A	Flare Type RT	N/A
N/A	Flare Slope LT (%)	N/A	N/A	Flare Slope RT (%)	N/A
N/A	Flare Traversable LT?	N/A	N/A	Flare Traversable RT?	N/A
N/A	Landing Length (in)	N/A	N/A	DWS Provided?	N/A
N/A	Landing Width (in)	N/A	N/A	DWS Contrast?	N/A
N/A	Landing Slope (%)	N/A	N/A	DWS Length (in)	N/A
N/A	Landing X Slope (%)	N/A	N/A	DWS Full Width?	N/A
N/A	Landing Curb? (Y/N)	N/A	N/A	DWS Offset (in)	N/A
N/A	Shared Landing?	N/A			
N/A	Gutter Ponding?	N/A	N/A	Gutter Slope (%)	N/A
N/A	Gutter Lip Ht (in)	N/A	N/A	Gutter X Slope (%)	N/A
N/A	Painted X Walk1?	No	N/A	Painted X Walk2?	N/A
	X Walk 1 Direction	To NE		X Walk 2 Direction	N/A
N/A	X Walk 1 Width (in)	N/A	N/A	X Walk 2 Width (in)	N/A
	X Walk 1 Slope (%)	2.2		X Walk 2 Slope (%)	N/A
	X Walk 1 X Slope (%)	0.3		X Walk 2 X Slope (%)	N/A

N/A	Ramp inside XWalk1?	N/A	N/A	Ramp inside XWalk2?	N/A
	Road Slope (%)	N/A	N/A	Clear Space?	N/A
	Road X Slope (%)	N/A	N/A	Clear Space to XWalk (in)	N/A
N/A	Any Obstructions?	N/A	N/A	Storm Grate/Utility Hazard?	N/A
	Obstruction Type			Storm Grate/Utility Type	
		N/A			N/A
			Yes	Surface Condition? (G/P)	Good

Remove & Replace Entire Ramp.
