Access Compliance Report

Public Rights-of-Way

(Curb Ramps)

Intersection ID: 29917	Main Street: BEMBRIDGE_CT	Cross Street: NORTHRIDGE_DR	Location: SW
ADA ID: EFF843D0756E	Ramp Type: Perp	Initial Pass/Fail: Fail	Overall Compliance: No
		Severity Score: 12.5

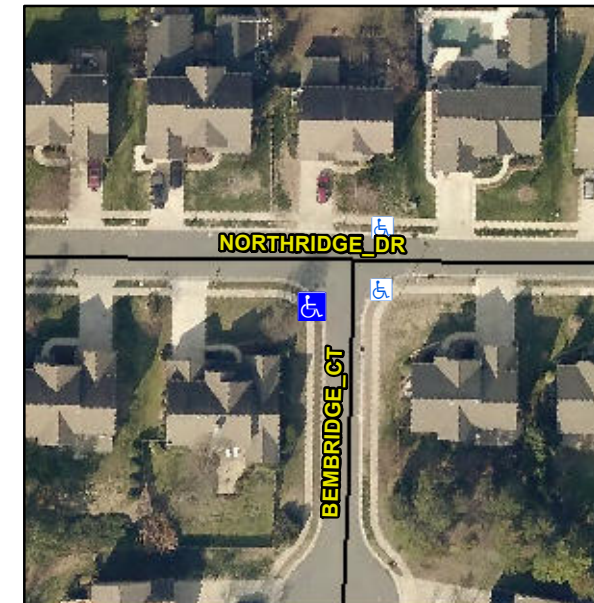
Compliance	Description	Data	Compliance	Description	Data
N/A	Ramp Length (in)	94.5	Yes	Ramp Slope (%)	8.3
Yes	Ramp Width (in)	54.0	No	Ramp XSlope (%)	6.4
N/A	Flare Type LT	N/A	N/A	Flare Type RT	N/A
N/A	Flare Slope LT (%)	N/A	N/A	Flare Slope RT (%)	N/A
N/A	Flare Traversable LT?	N/A	N/A	Flare Traversable RT?	N/A
N/A	Landing Length (in)	N/A	N/A	DWS Provided?	N/A
N/A	Landing Width (in)	N/A	N/A	DWS Contrast?	N/A
N/A	Landing Slope (%)	N/A	N/A	DWS Length (in)	N/A
N/A	Landing X Slope (%)	N/A	N/A	DWS Full Width?	N/A
N/A	Landing Curb? (Y/N)	N/A	N/A	DWS Offset (in)	N/A
N/A	Shared Landing?	N/A			
N/A	Gutter Ponding?	N/A	N/A	Gutter Slope (%)	N/A
N/A	Gutter Lip Ht (in)	N/A	N/A	Gutter X Slope (%)	N/A
N/A	Painted X Walk1?	No	N/A	Painted X Walk2?	N/A
	X Walk 1 Direction	To E		X Walk 2 Direction	N/A
N/A	X Walk 1 Width (in)	N/A	N/A	X Walk 2 Width (in)	N/A
	X Walk 1 Slope (%)	0.4		X Walk 2 Slope (%)	N/A
	X Walk 1 X Slope (%)	6.4		X Walk 2 X Slope (%)	N/A

N/A	Ramp inside XWalk1?	N/A	N/A	Ramp inside XWalk2?	N/A
	Road Slope (%)	N/A	N/A	Clear Space?	N/A
	Road X Slope (%)	N/A	N/A	Clear Space to XWalk (in)	N/A
N/A	Any Obstructions?	N/A	N/A	Storm Grate/Utility Hazard?	N/A
	Obstruction Type			Storm Grate/Utility Type	
		N/A			N/A
			Yes	Surface Condition? (G/P)	Good

Remove & Replace Entire Ramp.

R304.5.3

\$ 1850.00
