Access Compliance Report

Public Rights-of-Way

(Curb Ramps)

Intersection ID: 13786	Main Street: E_7TH_ST	Cross Street: LAMAR_AV	Location: S
ADA ID: EFF9F8AB5B41	Ramp Type: Perp	Initial Pass/Fail: Fail	Overall Compliance: No
		Severity Score: 10

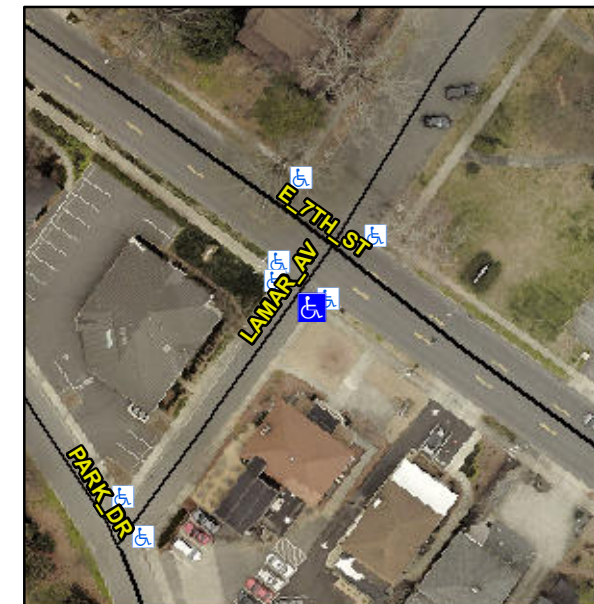
Not Found, R304.5.1, R304.5.3

Compliance	Description	Data	Compliance	Description	Data
N/A	Ramp Length (in)	24.0	Yes	Ramp Slope (%)	6.5
No	Ramp Width (in)	45.0	No	Ramp XSlope (%)	4.1
N/A	Flare Type LT	N/A	N/A	Flare Type RT	N/A
N/A	Flare Slope LT (%)	N/A	N/A	Flare Slope RT (%)	N/A
N/A	Flare Traversable LT?	N/A	N/A	Flare Traversable RT?	N/A
N/A	Landing Length (in)	N/A	N/A	DWS Provided?	N/A
N/A	Landing Width (in)	N/A	N/A	DWS Contrast?	N/A
N/A	Landing Slope (%)	N/A	N/A	DWS Length (in)	N/A
N/A	Landing X Slope (%)	N/A	N/A	DWS Full Width?	N/A
N/A	Landing Curb? (Y/N)	N/A	N/A	DWS Offset (in)	N/A
N/A	Shared Landing?	N/A			
N/A	Gutter Ponding?	N/A	N/A	Gutter Slope (%)	N/A
N/A	Gutter Lip Ht (in)	0.5	N/A	Gutter X Slope (%)	N/A
N/A	Painted X Walk1?	No	N/A	Painted X Walk2?	N/A
	X Walk 1 Direction	To NW		X Walk 2 Direction	N/A
N/A	X Walk 1 Width (in)	N/A	N/A	X Walk 2 Width (in)	N/A
	X Walk 1 Slope (%)	1.5		X Walk 2 Slope (%)	N/A
	X Walk 1 X Slope (%)	1.3		X Walk 2 X Slope (%)	N/A

Remove & Replace Entire Ramp.
