## Access Compliance Report Public Rights-of-Way (Curb Ramps)

Intersection ID: 11363 Main Street: N\_POPLAR\_ST Cross Street: W\_12TH\_ST Location: E

ADA ID: EFFE940C423B Ramp Type: Para Initial Pass/Fail: Fail Overall Compliance: No Severity Score: 12.5

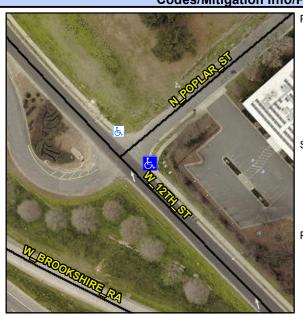
RT RP < 5%

R304.3.2

Field Measureme Compliance Description		Data	Compliance Description		Data
N/A	Ramp Length LT (in)	37.5	N/A	Ramp Length RT (in)	21.5
Yes	Ramp Width LT (in)	65.5	Yes	Ramp Width RT (in)	57.5
No	Ramp Slope LT (%)	10.4	Yes	Ramp Slope RT (%)	0.8
Yes	Ramp XSlope LT (%)	0.1	Yes	Ramp XSlope RT (%)	1.1
N/A	Landing Length (in)	N/A	N/A	DWS Provided?	N/A
N/A	Landing Width (in)	N/A	N/A	DWS Contrast?	N/A
N/A	Landing Slope (%)	N/A	N/A	DWS Length (in)	N/A
N/A	Landing X Slope (%)	N/A	N/A	DWS Full Width?	N/A
N/A	Landing Curb? (Y/N)	N/A	N/A	DWS Offset (in)	N/A
N/A	Shared Landing?	N/A		( )	
N/A	Gutter Ponding?	N/A	N/A	Gutter Slope (%)	N/A
N/A	Gutter Lip Ht (in)	1.5	N/A	Gutter X Slope (%)	N/A
N/A	Painted X Walk1?	No	N/A	Painted X Walk2?	N/A
	X Walk 1 Direction	To NW		X Walk 2 Direction	N/A
N/A	X Walk 1 Width (in)	N/A	N/A	X Walk 2 Width (in)	N/A
	X Walk 1 Slope (%)	4.0		X Walk 2 Slope (%)	N/A
	X Walk 1 X Slope (%)	1.7		X Walk 2 X Slope (%)	N/A

•	N/A			N/A
			Yes	Surface Condition? (G/P)	Good
			N/A	Curb Slope (%)	36.8

Remove & Replace Entire Ramp.

Total Cost: \$ 1600.00
