Access Compliance Report

Public Rights-of-Way

(Curb Ramps)

Intersection ID: 6611	Main Street: N_TRYON_ST	Cross Street: W_ROCKY_RIVER_RD	Location: S
ADA ID: EFFF03C05E3B	Ramp Type: Perp	Initial Pass/Fail: Fail	Overall Compliance: No
Severity Score: 12.5			
Codes/Mitigation Info/Possible Solution		Field Measurements/Component Compliance

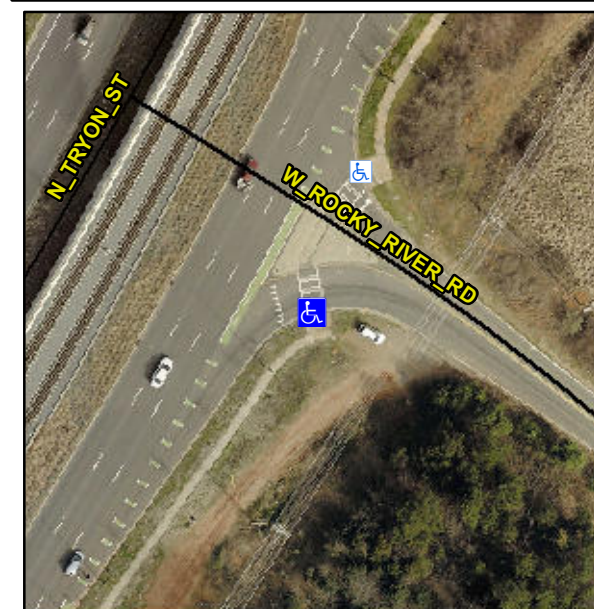
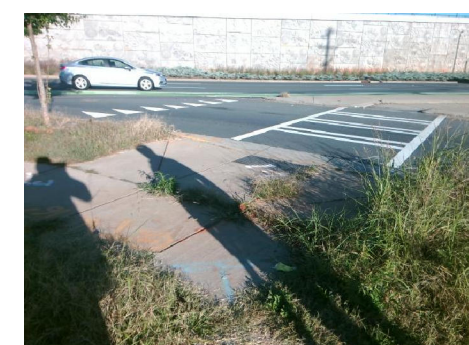
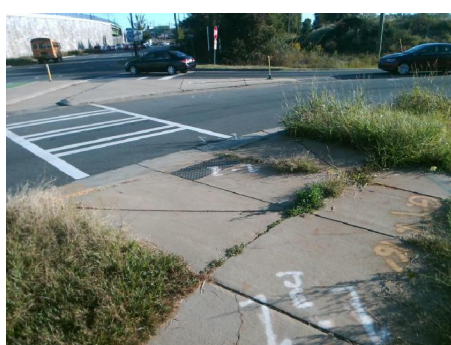
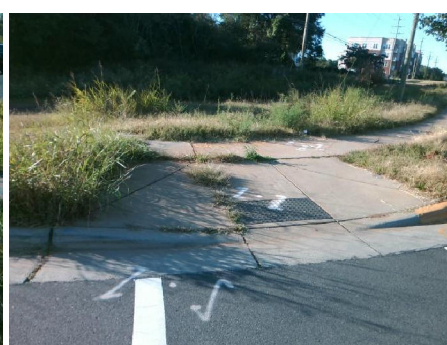
Not Found, R304.2.2

Compliance	Description	Data	Compliance	Description	Data
N/A	Ramp Length (in)	96.0	No	Ramp Slope (%)	9.4
Yes	Ramp Width (in)	48.0	Yes	Ramp XSlope (%)	0.1
N/A	Flare Type LT	N/A	N/A	Flare Type RT	N/A
N/A	Flare Slope LT (%)	N/A	N/A	Flare Slope RT (%)	N/A
N/A	Flare Traversable LT?	N/A	N/A	Flare Traversable RT?	N/A
N/A	Landing Length (in)	N/A	N/A	DWS Provided?	N/A
N/A	Landing Width (in)	N/A	N/A	DWS Contrast?	N/A
N/A	Landing Slope (%)	N/A	N/A	DWS Length (in)	N/A
N/A	Landing X Slope (%)	N/A	N/A	DWS Full Width?	N/A
N/A	Landing Curb? (Y/N)	N/A	N/A	DWS Offset (in)	N/A
N/A	Shared Landing?	N/A			
N/A	Gutter Ponding?	N/A	N/A	Gutter Slope (%)	N/A
N/A	Gutter Lip Ht (in)	N/A	N/A	Gutter X Slope (%)	N/A
N/A	Painted X Walk1?	Yes	N/A	Painted X Walk2?	N/A
	X Walk 1 Direction	To NE		X Walk 2 Direction	N/A
N/A	X Walk 1 Width (in)	114.5	N/A	X Walk 2 Width (in)	N/A
	X Walk 1 Slope (%)	0.1		X Walk 2 Slope (%)	N/A
	X Walk 1 X Slope (%)	0.6		X Walk 2 X Slope (%)	N/A

N/A	Ramp inside XWalk1?	Yes	N/A	Ramp inside XWalk2?	N/A
	Road Slope (%)	N/A	N/A	Clear Space?	N/A
	Road X Slope (%)	N/A	N/A	Clear Space to XWalk (in)	N/A
N/A	Any Obstructions?	N/A	N/A	Storm Grate/Utility Hazard?	N/A
	Obstruction Type			Storm Grate/Utility Type	
		N/A			N/A
		Yes		Surface Condition? (G/P)	Good

Remove & Replace Entire Ramp.

Total Cost: \$ 1850.00
