Access Compliance Report

Public Rights-of-Way

(Curb Ramps)

Intersection ID: 19209	Main Street: LIVINGSTON_DR	Cross Street: SARDIS_RD	Location: NE
ADA ID: F00DB29DA81A	Ramp Type: Perp	Initial Pass/Fail: Fail	Overall Compliance: No
		Severity Score: 10

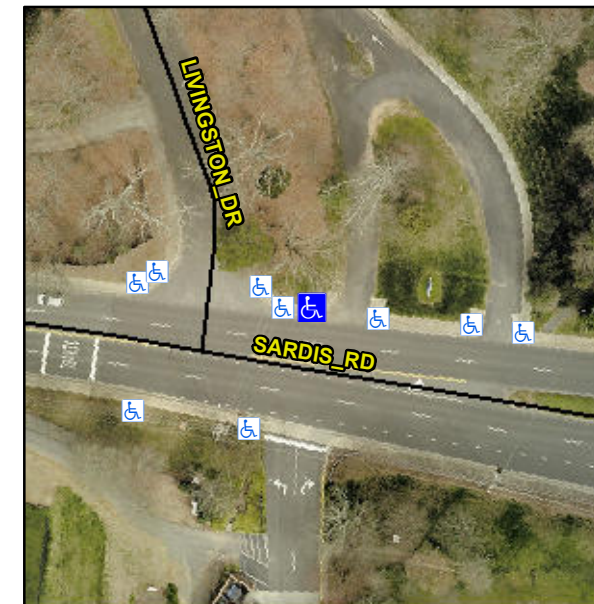
Not Found, R304.5.1, R304.5.3

Compliance	Description	Data	Compliance	Description	Data
N/A	Ramp Length (in)	60.0	Yes	Ramp Slope (%)	8.1
No	Ramp Width (in)	38.0	No	Ramp XSlope (%)	2.5
N/A	Flare Type LT	N/A	N/A	Flare Type RT	N/A
N/A	Flare Slope LT (%)	N/A	N/A	Flare Slope RT (%)	N/A
N/A	Flare Traversable LT?	N/A	N/A	Flare Traversable RT?	N/A
N/A	Landing Length (in)	N/A	N/A	DWS Provided?	N/A
N/A	Landing Width (in)	N/A	N/A	DWS Contrast?	N/A
N/A	Landing Slope (%)	N/A	N/A	DWS Length (in)	N/A
N/A	Landing X Slope (%)	N/A	N/A	DWS Full Width?	N/A
N/A	Landing Curb? (Y/N)	N/A	N/A	DWS Offset (in)	N/A
N/A	Shared Landing?	N/A			
N/A	Gutter Ponding?	N/A	N/A	Gutter Slope (%)	N/A
N/A	Gutter Lip Ht (in)	N/A	N/A	Gutter X Slope (%)	N/A
N/A	Painted X Walk1?	No	N/A	Painted X Walk2?	N/A
	X Walk 1 Direction	To SE		X Walk 2 Direction	N/A
N/A	X Walk 1 Width (in)	N/A	N/A	X Walk 2 Width (in)	N/A
	X Walk 1 Slope (%)	1.3		X Walk 2 Slope (%)	N/A
	X Walk 1 X Slope (%)	0.0		X Walk 2 X Slope (%)	N/A

Remove & Replace Entire Ramp.
