Access Compliance Report

Public Rights-of-Way

(Curb Ramps)

Intersection ID: N/A	Main Street: SMITHFIELD_RD	Cross Street: AVONCLIFF_DR	Location: S
ADA ID: F00F3830DF39	Ramp Type: Perp	Initial Pass/Fail: Pass	Overall Compliance: No
Codes/Mitigation Info/Possible Solution		Field Measurements/Component Compliance	
Severity Score: 7.75

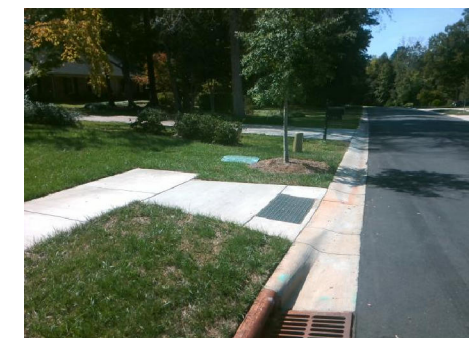
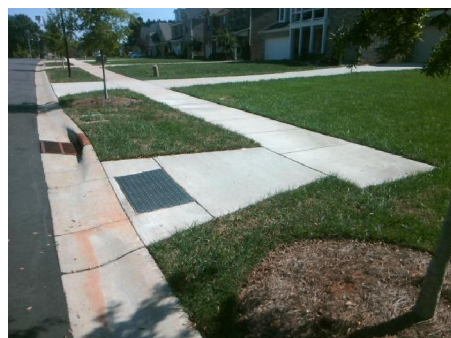
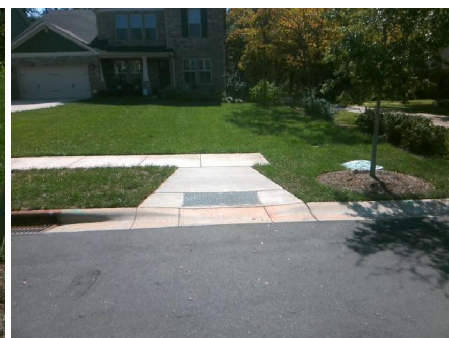
Compliance	Description	Data	Compliance	Description	Data
N/A	Ramp Length (in)	95.0	Yes	Ramp Slope (%)	5.8
Yes	Ramp Width (in)	48.0	Yes	Ramp XSlope (%)	2.1
N/A	Flare Type LT	Sloped	N/A	Flare Type RT	N/A
N/A	Flare Slope LT (%)	8.0	Yes	Flare Slope RT (%)	2.7
N/A	Flare Traversable LT?	Yes	N/A	Flare Traversable RT?	Yes
Yes	Landing Length (in)	60.0	Yes	DWS Provided?	Yes
Yes	Landing Width (in)	60.0	Yes	DWS Contrast?	Yes
Yes	Landing Slope (%)	2.0	Yes	DWS Length (in)	24.0
No	Landing X Slope (%)	3.2	No	DWS Full Width?	No
N/A	Landing Curb? (Y/N)	No	No	DWS Offset (in)	3.0
N/A	Shared Landing?	No			
Yes	Gutter Ponding?	No	No	Gutter Slope (%)	5.5
Yes	Gutter Lip Ht (in)	0.0	No	Gutter X Slope (%)	2.7
N/A	Painted X Walk1?	No	N/A	Painted X Walk2?	N/A
	X Walk 1 Direction	To NW		X Walk 2 Direction	N/A
N/A	X Walk 1 Width (in)	N/A	N/A	X Walk 2 Width (in)	N/A
	X Walk 1 Slope (%)	2.0		X Walk 2 Slope (%)	N/A
	X Walk 1 X Slope (%)	2.4		X Walk 2 X Slope (%)	N/A

N/A	Ramp inside XWalk1?	N/A	N/A	Ramp inside XWalk2?	N/A
	Road Slope (%)	N/A	N/A	Clear Space?	Yes
	Road X Slope (%)	N/A	N/A	Clear Space to XWalk (in)	N/A
Yes	Any Obstructions?	No	Yes	Storm Grate/Utility Hazard?	No
	Obstruction Type			Storm Grate/Utility Type	
		N/A			N/A
			Yes	Surface Condition? (G/P)	Good

Possible Solutions:

**Remove & Replace Entire Ramp.
Remove & Replace Gutter.**

R304.5.3, R305.1.4, R305.2, R304.5.4

Total Cost: \$ 2600.00
