Intersection ID: 6481	Main Street: LOTHAR_RIDGE_LN	Cross Street: SLATER_SPRINGS_DR	Location:	NW
ADA ID: F00FCCD7737C	Ramp Type: BlendTrans1	Initial Pass/Fail: Fail	Overall Compliance: No	Severity Score: 33.75

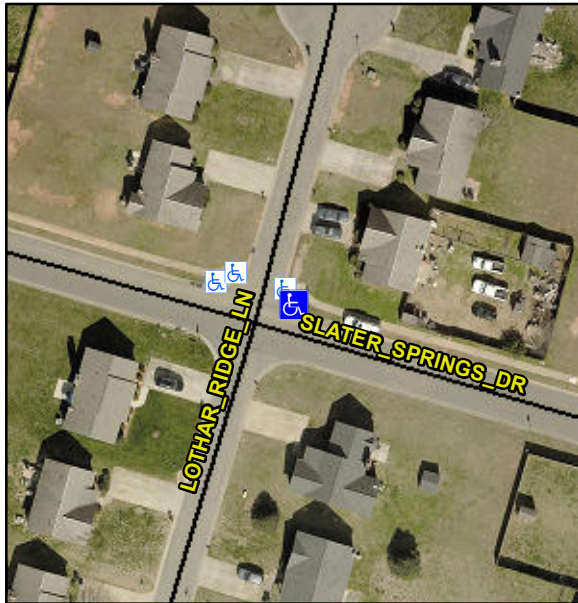
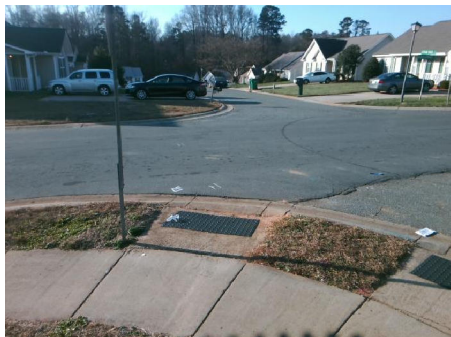
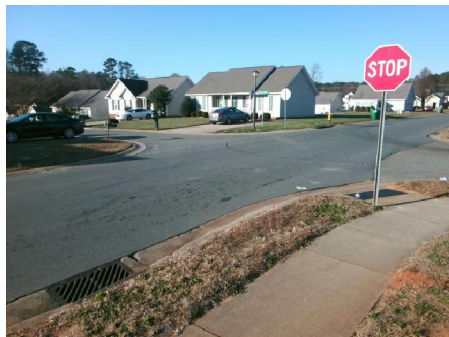
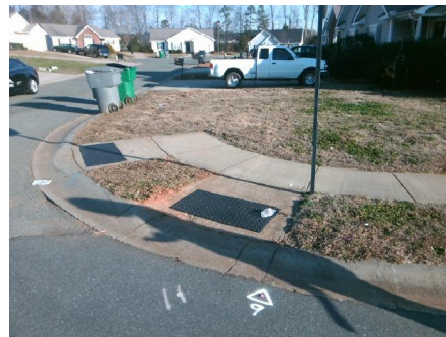
Not Found, R304.5.1, R304.5.3

Compliance	Description	Data	Compliance	Description	Data
N/A	Ramp Length (in)	53.0	Yes	BlendTrans Slope (%)	2.5
No	Ramp Width (in)	46.0	No	BlendTrans XSlope (%)	10.1
N/A	Flare Type LT	N/A	N/A	Flare Type RT	N/A
N/A	Flare Slope LT (%)	N/A	N/A	Flare Slope RT (%)	N/A
N/A	Flare Traversable LT?	N/A	N/A	Flare Traversable RT?	N/A
N/A	Landing Length (in)	N/A	N/A	DWS Provided?	N/A
N/A	Landing Width (in)	N/A	N/A	DWS Contrast?	N/A
N/A	Landing Slope (%)	N/A	N/A	DWS Length (in)	N/A
N/A	Landing X Slope (%)	N/A	N/A	DWS Full Width?	N/A
N/A	Landing Curb? (Y/N)	N/A	N/A	DWS Offset (in)	N/A
N/A	Shared Landing?	N/A			
N/A	Gutter Ponding?	N/A	N/A	Gutter Slope (%)	N/A
N/A	Gutter Lip Ht (in)	N/A	N/A	Gutter X Slope (%)	N/A
N/A	Painted X Walk1?	No	N/A	Painted X Walk2?	N/A
	X Walk 1 Direction	To S		X Walk 2 Direction	N/A
	X Walk 1 Width (in)	N/A		X Walk 2 Width (in)	N/A
	X Walk 1 Slope (%)	2.9		X Walk 2 Slope (%)	N/A
	X Walk 1 X Slope (%)	2.3		X Walk 2 X Slope (%)	N/A

N/A	Ramp inside XWalk1?	N/A	N/A	Ramp inside XWalk2?	N/A
	Road Slope (%)	2.3		Clear Space?	N/A
	Road X Slope (%)	2.9	N/A	Clear Space to XWalk (in)	N/A
N/A	Any Obstructions?	N/A	N/A	Storm Grate/Utility Hazard?	N/A
	Obstruction Type			Storm Grate/Utility Type	
		N/A			N/A
			Yes	Surface Condition? (G/P)	Good
			No	Curb Slope (%)	12.2

Remove & Replace Curb Ramp With Two New Directional Ramps or Equivalent.

Total Cost: \$ 3200.00
