Access Compliance Report

Public Rights-of-Way

(Curb Ramps)

Intersection ID: 28508	Main Street: AVIARY_HILL_WY	Cross Street: NATURE_PL	Location: SE
ADA ID: F011A463F31A	Ramp Type: Perp	Initial Pass/Fail: Fail	Overall Compliance: No
Severity Score: 31.25			
Codes/Mitigation Info/Possible Solution		Field Measurements/Component Compliance

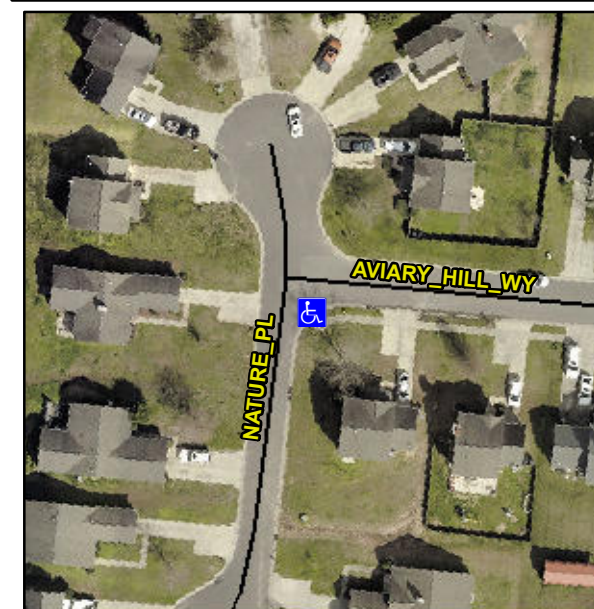
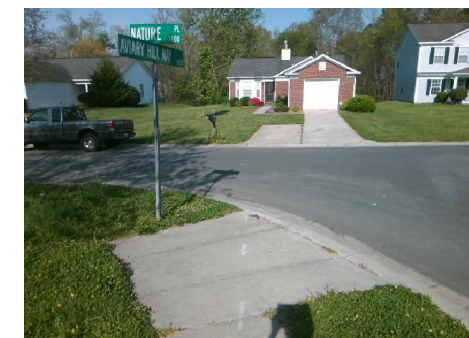
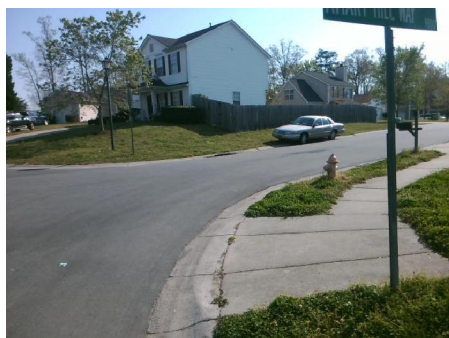
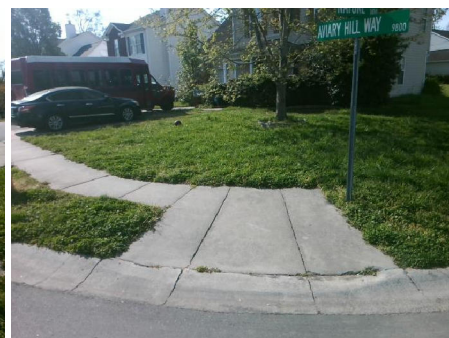
Not Found, R304.5.1, R304.2.2

Compliance	Description	Data	Compliance	Description	Data
N/A	Ramp Length (in)	99.0	No	Ramp Slope (%)	9.2
No	Ramp Width (in)	34.0	Yes	Ramp XSlope (%)	2.7
N/A	Flare Type LT	N/A	N/A	Flare Type RT	N/A
N/A	Flare Slope LT (%)	N/A	N/A	Flare Slope RT (%)	N/A
N/A	Flare Traversable LT?	N/A	N/A	Flare Traversable RT?	N/A
N/A	Landing Length (in)	N/A	N/A	DWS Provided?	N/A
N/A	Landing Width (in)	N/A	N/A	DWS Contrast?	N/A
N/A	Landing Slope (%)	N/A	N/A	DWS Length (in)	N/A
N/A	Landing X Slope (%)	N/A	N/A	DWS Full Width?	N/A
N/A	Landing Curb? (Y/N)	N/A	N/A	DWS Offset (in)	N/A
N/A	Shared Landing?	N/A			
N/A	Gutter Ponding?	N/A	N/A	Gutter Slope (%)	N/A
N/A	Gutter Lip Ht (in)	N/A	N/A	Gutter X Slope (%)	N/A
N/A	Painted X Walk1?	No	N/A	Painted X Walk2?	N/A
	X Walk 1 Direction	To W		X Walk 2 Direction	N/A
N/A	X Walk 1 Width (in)	N/A	N/A	X Walk 2 Width (in)	N/A
	X Walk 1 Slope (%)	2.8		X Walk 2 Slope (%)	N/A
	X Walk 1 X Slope (%)	3.6		X Walk 2 X Slope (%)	N/A

N/A	Ramp inside XWalk1?	N/A	N/A	Ramp inside XWalk2?	N/A
	Road Slope (%)	3.6	N/A	Clear Space?	N/A
	Road X Slope (%)	2.8	N/A	Clear Space to XWalk (in)	N/A
N/A	Any Obstructions?	N/A	N/A	Storm Grate/Utility Hazard?	N/A
	Obstruction Type			Storm Grate/Utility Type	
		N/A			N/A
		Yes		Surface Condition? (G/P)	Good

Remove & Replace Entire Ramp.
