# Access Compliance Report

## Public Rights-of-Way

### (Curb Ramps)

Intersection ID: 30117	Main Street: CLOONEY_LN	Cross Street: DAVIS_FOREST_LN	Location: SE
ADA ID: F01739E745A9	Ramp Type: Perp	Initial Pass/Fail: Fail	Overall Compliance: No
Severity Score: 10			
Codes/Mitigation Info/Possible Solution		Field Measurements/Component Compliance

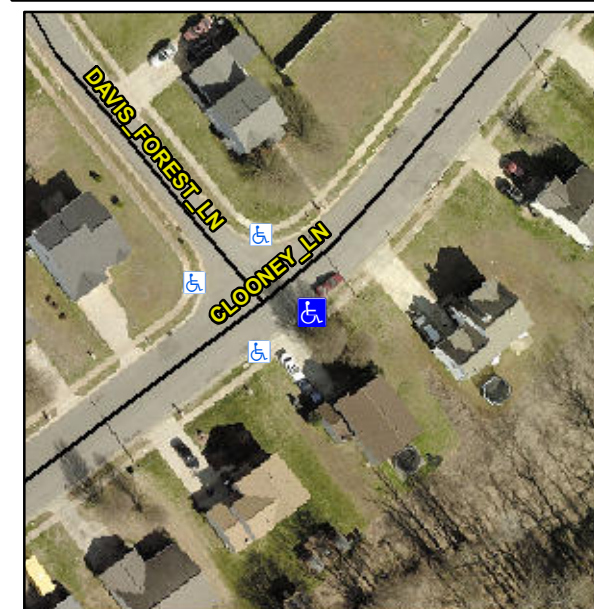
Compliance	Description	Data	Compliance	Description	Data
N/A	Ramp Length (in)	47.5	Yes	Ramp Slope (%)	6.8
No	Ramp Width (in)	42.0	Yes	Ramp XSlope (%)	2.4
N/A	Flare Type LT	N/A	N/A	Flare Type RT	N/A
N/A	Flare Slope LT (%)	N/A	N/A	Flare Slope RT (%)	N/A
N/A	Flare Traversable LT?	N/A	N/A	Flare Traversable RT?	N/A
N/A	Landing Length (in)	N/A	N/A	DWS Provided?	N/A
N/A	Landing Width (in)	N/A	N/A	DWS Contrast?	N/A
N/A	Landing Slope (%)	N/A	N/A	DWS Length (in)	N/A
N/A	Landing X Slope (%)	N/A	N/A	DWS Full Width?	N/A
N/A	Landing Curb? (Y/N)	N/A	N/A	DWS Offset (in)	N/A
N/A	Shared Landing?	N/A			
N/A	Gutter Ponding?	N/A	N/A	Gutter Slope (%)	N/A
N/A	Gutter Lip Ht (in)	N/A	N/A	Gutter X Slope (%)	N/A
N/A	Painted X Walk1?	No	N/A	Painted X Walk2?	N/A
	X Walk 1 Direction	To NW		X Walk 2 Direction	N/A
N/A	X Walk 1 Width (in)	N/A	N/A	X Walk 2 Width (in)	N/A
	X Walk 1 Slope (%)	0.2		X Walk 2 Slope (%)	N/A
	X Walk 1 X Slope (%)	4.6		X Walk 2 X Slope (%)	N/A

N/A	Ramp inside XWalk1?	N/A	N/A	Ramp inside XWalk2?	N/A
	Road Slope (%)	N/A	N/A	Clear Space?	N/A
	Road X Slope (%)	N/A	N/A	Clear Space to XWalk (in)	N/A
N/A	Any Obstructions?	N/A	N/A	Storm Grate/Utility Hazard?	N/A
	Obstruction Type			Storm Grate/Utility Type	
		N/A			N/A
			Yes	Surface Condition? (G/P)	Good

Possible Solutions:

**Remove & Replace Entire Ramp.**

**R304.5.1**

**\$ 1850.00**
