Access Compliance Report Public Rights-of-Way (Curb Ramps)

Intersection ID: 25138 Main Street: CHAPEL CREEK CT **Cross Street: MEADOWRIDGE DR** Location: NE **ADA ID: F01C2E974FF6** Ramp Type: PerpDiag Initial Pass/Fail: Fail **Overall Compliance: No Severity Score:** 8.75

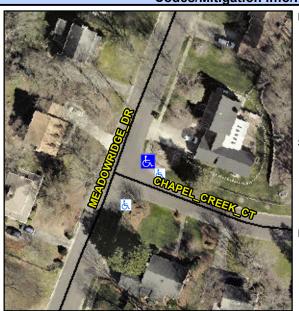
Field Measurements/Component Compliance						
Compliance Description		Data	Comp	liance	Description	Data
N/A	Ramp Length (in)	54.0	Yes	Ramp	Slope (%)	6.5
No	Ramp Width (in)	41.0	Yes	Ramp	XSlope (%)	0.7
N/A	Flare Type LT	N/A	N/A	Flare	Type RT	N/A
N/A	Flare Slope LT (%)	N/A	N/A	Flare	Slope RT (%)	N/A
N/A	Flare Traversable LT?	N/A	N/A	Flare	Traversable RT?	N/A
N/A	Landing Length (in)	N/A	N/A	DWS	Provided?	N/A
N/A	Landing Width (in)	N/A	N/A	DWS	Contrast?	N/A
N/A	Landing Slope (%)	N/A	N/A	DWS	Length (in)	N/A
N/A	Landing X Slope (%)	N/A	N/A	DWS	Full Width?	N/A
N/A	Landing Curb? (Y/N)	N/A	N/A	DWS	Offset (in)	N/A
N/A	Shared Landing?	N/A				
N/A	Gutter Ponding?	N/A	N/A	Gutte	r Slope (%)	N/A
N/A	Gutter Lip Ht (in)	N/A	N/A	Gutte	r X Slope (%)	N/A
N/A	Painted X Walk1?	No	N/A	Painte	ed X Walk2?	No
	X Walk 1 Direction	To NW		X Wa	lk 2 Direction	To SW
N/A	X Walk 1 Width (in)	N/A	N/A	X Wa	lk 2 Width (in)	N/A
	X Walk 1 Slope (%)	1.9		X Wa	lk 2 Slope (%)	3.3

X Walk 1 X Slope (%)	2.5		X Wa	lk 2 X Slope (%)	0.3
N/A	Ramp inside XWalk1?	N/A	N/A	Ramp	inside XWalk2?	N/A
	Road Slope (%)	1.5	N/A	Clear	Space?	N/A
	Road X Slope (%)	4.2	N/A	Clear	Space to XWalk (in)	N/A
N/A	Any Obstructions?	N/A	N/A	Storm	Grate/Utility Hazard?	N/A
	Obstruction Type			Storm	Grate/Utility Type	
		N/A				N/A
			Yes	Surfa	ce Condition? (G/P)	Good

Possible Solutions: Remove & Replace Curb Ramp With Two New Directional Ramps or Equivalent. Surveyor Notes: N/A PROW/ADA: Not Found, R304.5.1
