Access Compliance Report

Public Rights-of-Way

(Curb Ramps)

Intersection ID: 28526	Main Street: ROLLINGBROOK_DR	Cross Street: TYVOLA_CENTRE_DR	Location: NE
ADA ID: F01FAC0EBF6C	Ramp Type: Directional1	Initial Pass/Fail: Fail	Overall Compliance: No
Severity Score: 12.5			
Codes/Mitigation Info/Possible Solution		Field Measurements/Component Compliance

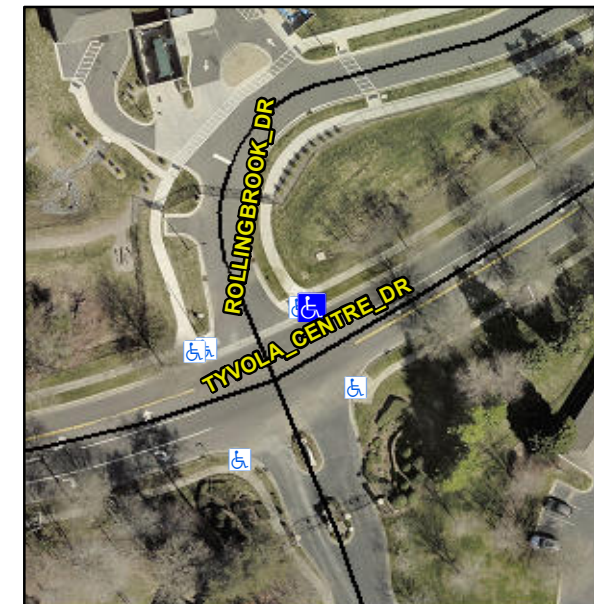
Compliance	Description	Data	Compliance	Description	Data
N/A	Ramp Length (in)	57.0	N/A	Grade Break?	N/A
Yes	Ramp Width (in)	56.0	N/A	Grade Break Slope (%)	0.0
No	Ramp Slope (%)	8.9	N/A	Grade Break XSlope (%)	0.0
Yes	Ramp XSlope (%)	0.5			
N/A	Flare Type LT	N/A	N/A	Flare Type RT	N/A
N/A	Flare Slope LT (%)	N/A	N/A	Flare Slope RT (%)	0.0
N/A	Flare Traversable LT?	N/A	N/A	Flare Traversable RT?	N/A
N/A	Landing Length (in)	0.0	N/A	DWS Provided?	N/A
N/A	Landing Width (in)	0.0	N/A	DWS Contrast?	N/A
N/A	Landing Slope (%)	0.0	N/A	DWS Length (in)	N/A
N/A	Landing X Slope (%)	0.0	N/A	DWS Full Width?	N/A
N/A	Landing Curb? (Y/N)	N/A	N/A	DWS Offset LT (in)	N/A
N/A	Shared Landing?	N/A	N/A	DWS Offset RT (in)	N/A
N/A	Gutter Ponding?	0.0	N/A	Gutter Slope (%)	N/A
N/A	Gutter Lip Ht (in)	0.0	N/A	Gutter X Slope (%)	N/A
N/A	Painted X Walk1?	No		Road Slope (%)	4.1
	X Walk 1 Direction	To SE		Road X Slope (%)	1.6
	X Walk 1 Width (in)	N/A		Clear Space?	N/A

X Walk 1 Slope (%)	4.1	N/A	Clear Space to XWalk (in)	N/A
	X Walk 1 X Slope (%)	1.6	N/A	Storm Grate/Utility Hazard?	N/A
N/A	Ramp inside XWalk1?	N/A		Storm Grate/Utility Type	
N/A	Any Obstructions?	N/A			N/A
	Obstruction Type		Yes	Surface Condition? (G/P)	Good
			N/A	Curb Slope (%)	12.5

Possible Solutions:

Remove & Replace Entire Ramp.

R304.2.2
