Access Compliance Report

Public Rights-of-Way

(Curb Ramps)

Intersection ID: 15598	Main Street: MONROE_RD	Cross Street: VINEWOOD_PL	Location: NE
ADA ID: F021D317D185	Ramp Type: PerpDiag	Initial Pass/Fail: Fail	Overall Compliance: No
Codes/Mitigation Info/Possible Solution		Field Measurements/Component Compliance

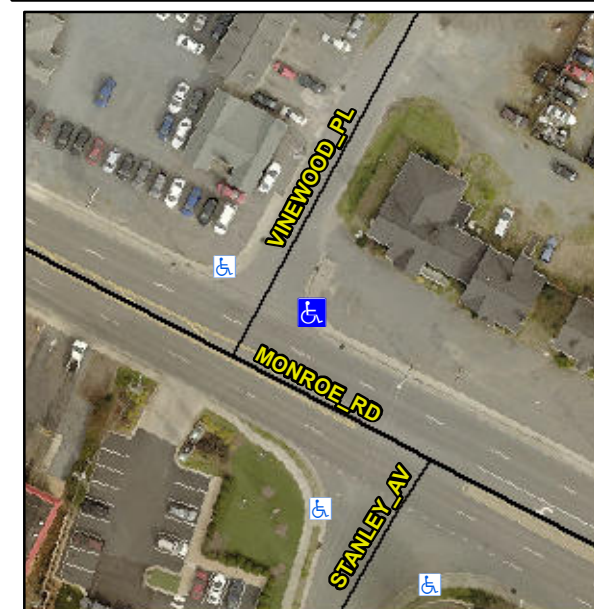
PROW/ADA:

Not Found, R304.5.1, R304.2.2

Compliance	Description	Data	Compliance	Description	Data
N/A	Ramp Length (in)	60.0	No	Ramp Slope (%)	9.2
No	Ramp Width (in)	43.0	Yes	Ramp XSlope (%)	1.7
N/A	Flare Type LT	N/A	N/A	Flare Type RT	N/A
N/A	Flare Slope LT (%)	N/A	N/A	Flare Slope RT (%)	N/A
N/A	Flare Traversable LT?	N/A	N/A	Flare Traversable RT?	N/A
N/A	Landing Length (in)	N/A	N/A	DWS Provided?	N/A
N/A	Landing Width (in)	N/A	N/A	DWS Contrast?	N/A
N/A	Landing Slope (%)	N/A	N/A	DWS Length (in)	N/A
N/A	Landing X Slope (%)	N/A	N/A	DWS Full Width?	N/A
N/A	Landing Curb? (Y/N)	N/A	N/A	DWS Offset (in)	N/A
N/A	Shared Landing?	N/A			
N/A	Gutter Ponding?	N/A	N/A	Gutter Slope (%)	N/A
N/A	Gutter Lip Ht (in)	N/A	N/A	Gutter X Slope (%)	N/A
N/A	Painted X Walk1?	No	N/A	Painted X Walk2?	No
	X Walk 1 Direction	To NW		X Walk 2 Direction	To SW
N/A	X Walk 1 Width (in)	N/A	N/A	X Walk 2 Width (in)	N/A
	X Walk 1 Slope (%)	1.3		X Walk 2 Slope (%)	1.1
	X Walk 1 X Slope (%)	2.6		X Walk 2 X Slope (%)	1.7

N/A	Ramp inside XWalk1?	N/A	N/A	Ramp inside XWalk2?	N/A
	Road Slope (%)	2.6	N/A	Clear Space?	N/A
	Road X Slope (%)	0.5	N/A	Clear Space to XWalk (in)	N/A
N/A	Any Obstructions?	N/A	N/A	Storm Grate/Utility Hazard?	N/A
	Obstruction Type			Storm Grate/Utility Type	
		N/A			N/A
			Yes	Surface Condition? (G/P)	Good

Possible Solutions:

Remove & Replace Curb Ramp With Two New Directional Ramps or Equivalent.
