Access Compliance Report

Public Rights-of-Way

(Curb Ramps)

Intersection ID: 3415	Main Street: WHITEWOOD_TL	Cross Street: POPLAR_GROVE_DR	Location: SE
ADA ID: F02A92168EAF	Ramp Type: Perp	Initial Pass/Fail: Fail	Overall Compliance: No
		Severity Score: 15

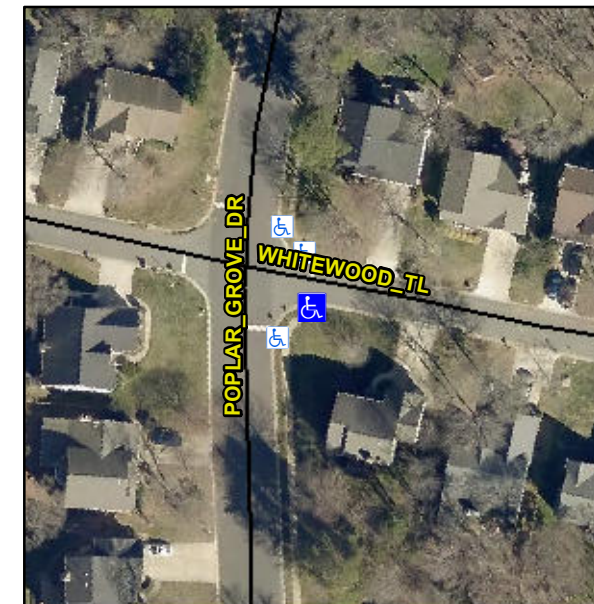
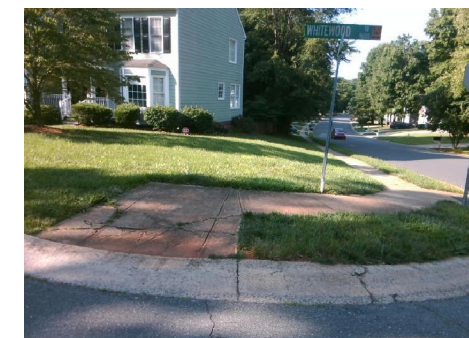
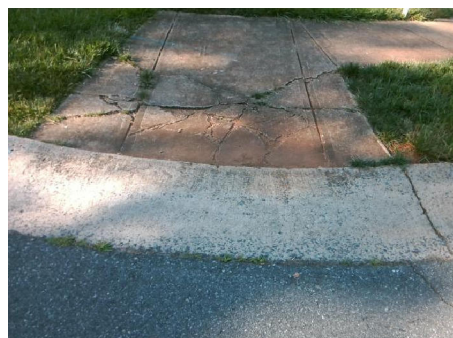
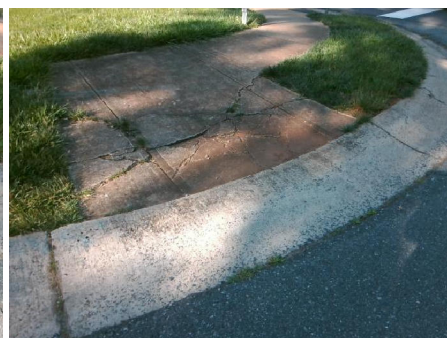
Not Found, R302.7

Compliance	Description	Data	Compliance	Description	Data
N/A	Ramp Length (in)	48.0	Yes	Ramp Slope (%)	5.1
Yes	Ramp Width (in)	48.0	Yes	Ramp XSlope (%)	0.1
N/A	Flare Type LT	N/A	N/A	Flare Type RT	N/A
N/A	Flare Slope LT (%)	N/A	N/A	Flare Slope RT (%)	N/A
N/A	Flare Traversable LT?	N/A	N/A	Flare Traversable RT?	N/A
N/A	Landing Length (in)	N/A	N/A	DWS Provided?	N/A
N/A	Landing Width (in)	N/A	N/A	DWS Contrast?	N/A
N/A	Landing Slope (%)	N/A	N/A	DWS Length (in)	N/A
N/A	Landing X Slope (%)	N/A	N/A	DWS Full Width?	N/A
N/A	Landing Curb? (Y/N)	N/A	N/A	DWS Offset (in)	N/A
N/A	Shared Landing?	N/A			
N/A	Gutter Ponding?	N/A	N/A	Gutter Slope (%)	N/A
N/A	Gutter Lip Ht (in)	N/A	N/A	Gutter X Slope (%)	N/A
N/A	Painted X Walk1?	No	N/A	Painted X Walk2?	N/A
	X Walk 1 Direction	To N		X Walk 2 Direction	N/A
N/A	X Walk 1 Width (in)	N/A	N/A	X Walk 2 Width (in)	N/A
	X Walk 1 Slope (%)	3.5		X Walk 2 Slope (%)	N/A
	X Walk 1 X Slope (%)	1.2		X Walk 2 X Slope (%)	N/A

N/A	Ramp inside XWalk1?	N/A	N/A	Ramp inside XWalk2?	N/A
	Road Slope (%)	N/A	N/A	Clear Space?	N/A
	Road X Slope (%)	N/A	N/A	Clear Space to XWalk (in)	N/A
N/A	Any Obstructions?	N/A	N/A	Storm Grate/Utility Hazard?	N/A
	Obstruction Type			Storm Grate/Utility Type	
		N/A			N/A
		No		Surface Condition? (G/P)	Poor

Possible Solutions:

Remove & Replace Entire Ramp.
