Access Compliance Report Public Rights-of-Way (Curb Ramps)

Intersection ID: 12411 Main Street: GREENLAND_AV Cross Street: W_MOREHEAD_ST Location: W

ADA ID: F02D5F157B2F Ramp Type: BlendTrans2 Initial Pass/Fail: Fail Overall Compliance: No Severity Score: 8.75

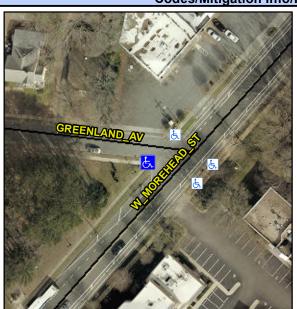
CURB LIP 1.5

R304.5.1

1 lola modear emente/ emperient compilance						
Compliance Description		Data	Compliance Description		Data	
N/A	Ramp Length (in)	87.0	Yes	BlendTrans Slope (%)	3.9	
No	Ramp Width (in)	47.5	Yes	BlendTrans XSlope (%)	1.9	
N/A	Flare Type LT	N/A	N/A	Flare Type RT	N/A	
N/A	Flare Slope LT (%)	N/A	N/A	Flare Slope RT (%)	N/A	
N/A	Flare Traversable LT?	N/A	N/A	Flare Traversable RT?	N/A	
N/A	Landing Length (in)	N/A	N/A	DWS Provided?	N/A	
N/A	Landing Width (in)	N/A	N/A	DWS Contrast?	N/A	
N/A	Landing Slope (%)	N/A	N/A	DWS Length (in)	N/A	
N/A	Landing X Slope (%)	N/A	N/A	DWS Full Width?	N/A	
N/A	Landing Curb? (Y/N)	N/A	N/A	DWS Offset (in)	N/A	
N/A	Shared Landing?	N/A				
N/A	Gutter Ponding?	Yes	N/A	Gutter Slope (%)	N/A	
N/A	Gutter Lip Ht (in)	N/A	N/A	Gutter X Slope (%)	N/A	
N/A	Painted X Walk1?	No	N/A	Painted X Walk2?	No	
	X Walk 1 Direction	To SE		X Walk 2 Direction	To NE	
	X Walk 1 Width (in)	N/A		X Walk 2 Width (in)	N/A

X Walk 1 Slope (%)	4.1		X Walk 2 Slope (%)	4.1	
	X Walk 1 X Slope (%)	0.1		X Walk 2 X Slope (%)	0.8	
N/A	Ramp inside XWalk1?	N/A	N/A	Ramp inside XWalk2?	N/A	
	Road Slope (%)	1.0		Clear Space?	N/A	
	Road X Slope (%)	3.4	N/A	Clear Space to XWalk (in)	N/A	
N/A	Any Obstructions?	N/A	N/A	Storm Grate/Utility Hazard?	N/A

Remove & Replace Curb Ramp With
Two New Directional Ramps or
Equivalent.
