## Access Compliance Report Public Rights-of-Way (Curb Ramps)

Intersection ID: 48373 Main Street: WHEATFIELD\_RD Cross Street: GARDEN\_VIEW\_DR Location: S

ADA ID: F02F5DF19596 Ramp Type: BlendTrans1 Initial Pass/Fail: Pass Overall Compliance: No Severity Score: 5

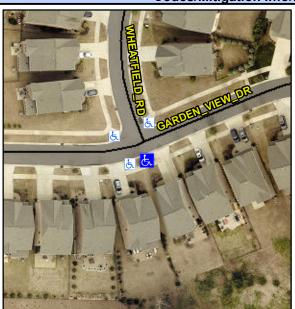
Compliance Description Data				liance Description	Data
N/A	Ramp Length (in)	95.0	Yes	BlendTrans Slope (%)	4.8
Yes	Ramp Width (in)	48.0	Yes	BlendTrans XSlope (%)	1.4
N/A	Flare Type LT	Sloped	N/A	Flare Type RT	Sloped
N/A	Flare Slope LT (%)	10.3	N/A	Flare Slope RT (%)	5.8
N/A	Flare Traversable LT?	No	N/A	Flare Traversable RT?	No
Yes	Landing Length (in)	60.0	Yes	DWS Provided?	Yes
Yes	Landing Width (in)	48.0	Yes	DWS Contrast?	Yes
No	Landing Slope (%)	2.6	Yes	DWS Length (in)	24.0
Yes	Landing X Slope (%)	0.1	Yes	DWS Full Width?	Yes
N/A	Landing Curb? (Y/N)	No	Yes	DWS Offset (in)	2.0
N/A	Shared Landing?	No			
Yes	Gutter Ponding?	No	No	Gutter Slope (%)	10.4
Yes	Gutter Lip Ht (in)	0.0	Yes	Gutter X Slope (%)	1.6
N/A	Painted X Walk1?	No	N/A	Painted X Walk2?	N/A
	X Walk 1 Direction	To NE		X Walk 2 Direction	N/A
	X Walk 1 Width (in)	N/A		X Walk 2 Width (in)	N/A
	X Walk 1 Slope (%)	3.1		X Walk 2 Slope (%)	N/A
	X Walk 1 X Slope (%)	1.7		X Walk 2 X Slope (%)	N/A

N/A	Ramp inside XWalk1?	N/A	N/A	Ramp inside XWalk2?	N/A
	Road Slope (%)	1.7		Clear Space?	Yes
	Road X Slope (%)	3.1	N/A	Clear Space to XWalk (in)	N/A
Yes	Any Obstructions?	No	Yes	Storm Grate/Utility Hazard?	No
	Obstruction Type			Storm Grate/Utility Type	
		N/A	l		N/A
			Yes	Surface Condition? (G/P)	Good
			No	Curb Slope (%)	8.5

Remove & Replace Curb Ramp With Two New Directional Ramps or Equivalent. Remove & Replace Gutter.
