Access Compliance Report Public Rights-of-Way (Curb Ramps)

Intersection ID: 45500 Main Street: GRASSY CROPS RD Cross Street: TRIPLE OAK RD Ε Location: **Overall Compliance: No Severity Score:** 0 ADA ID: F03F5DCD4AE1 Ramp Type: Combination1Diag Initial Pass/Fail: Fail

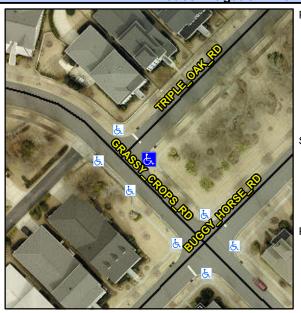
StopSign TRIPLE OAK RD None **GRASSY CROPS RD** Possible Solutions: Remove & Replace Curb Ramp With Two New Directional Ramps or Equivalent. Surveyor Notes: N/A PROW/ADA: Not Found, R304.5.1, R304.2.2, R304.5.3, R304.3.2
